# CONDITION REPORT

Artist on a tightrope in a prickly landscape, 1974

**CONDITION REPORT – Easel Paintings**
**Artist:** Stanley Pinker

**Acc No:** 74/22

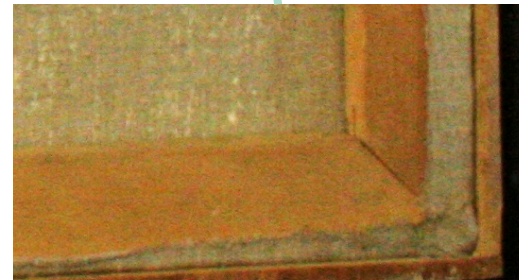
Not joined bottom left corner

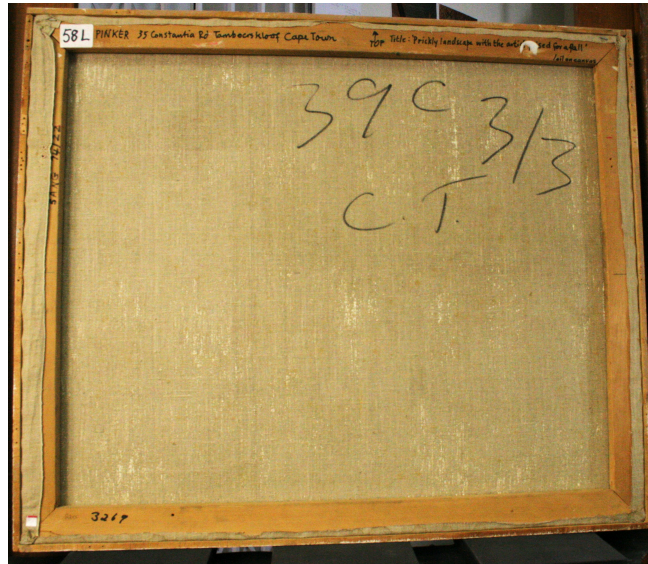
Close up highlighting tacking margins uneven distribution indicating that it was stretched by the artist

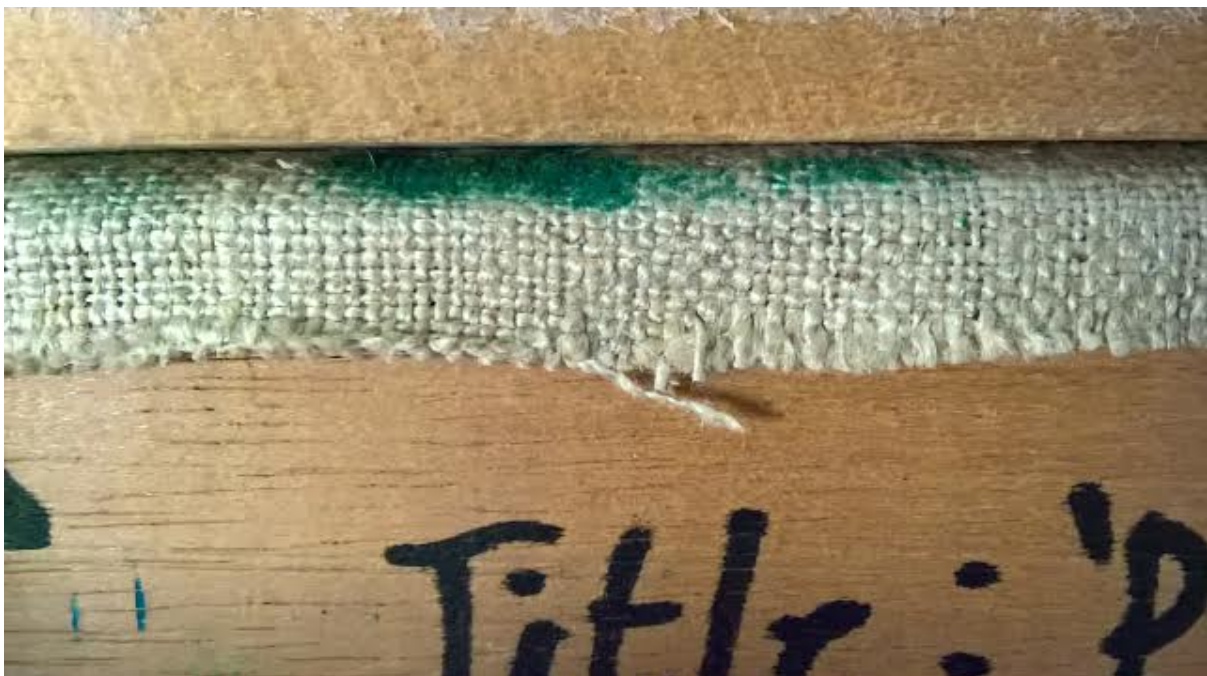
The condition of both the primary and lining canvas appear to be in a sound condition. A deformation extending from the upper right along the right edge indicates that the painting was made before it was stretched. Moreover, a selvedge along the middle right side of the canvas. Indicating that the canvas was stretched by the artist

Close up showing stretching of canvas once painting was created (Top left of painting)

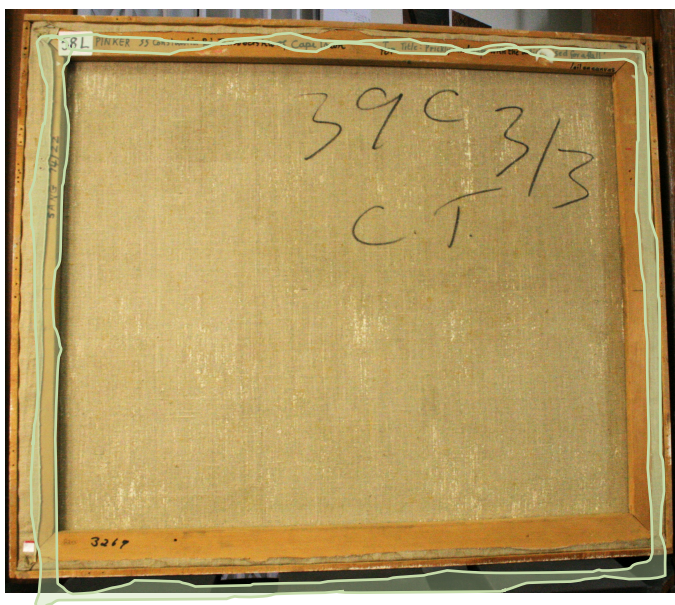
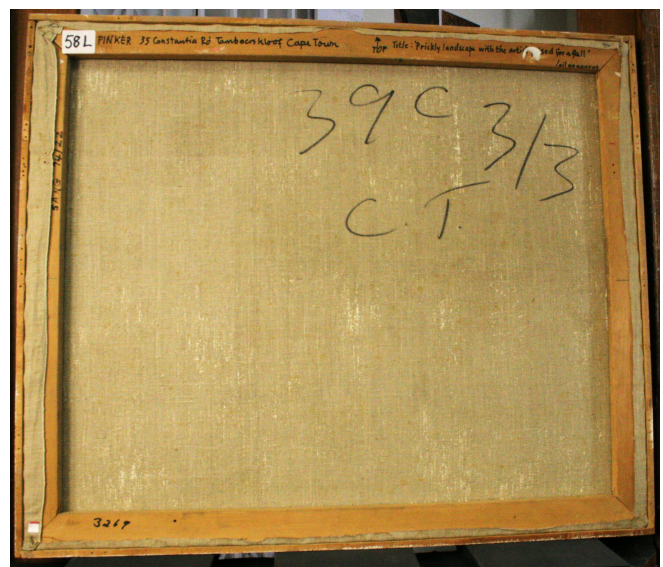
Uneven distribution of canvas indicating that it was streeched by the artist

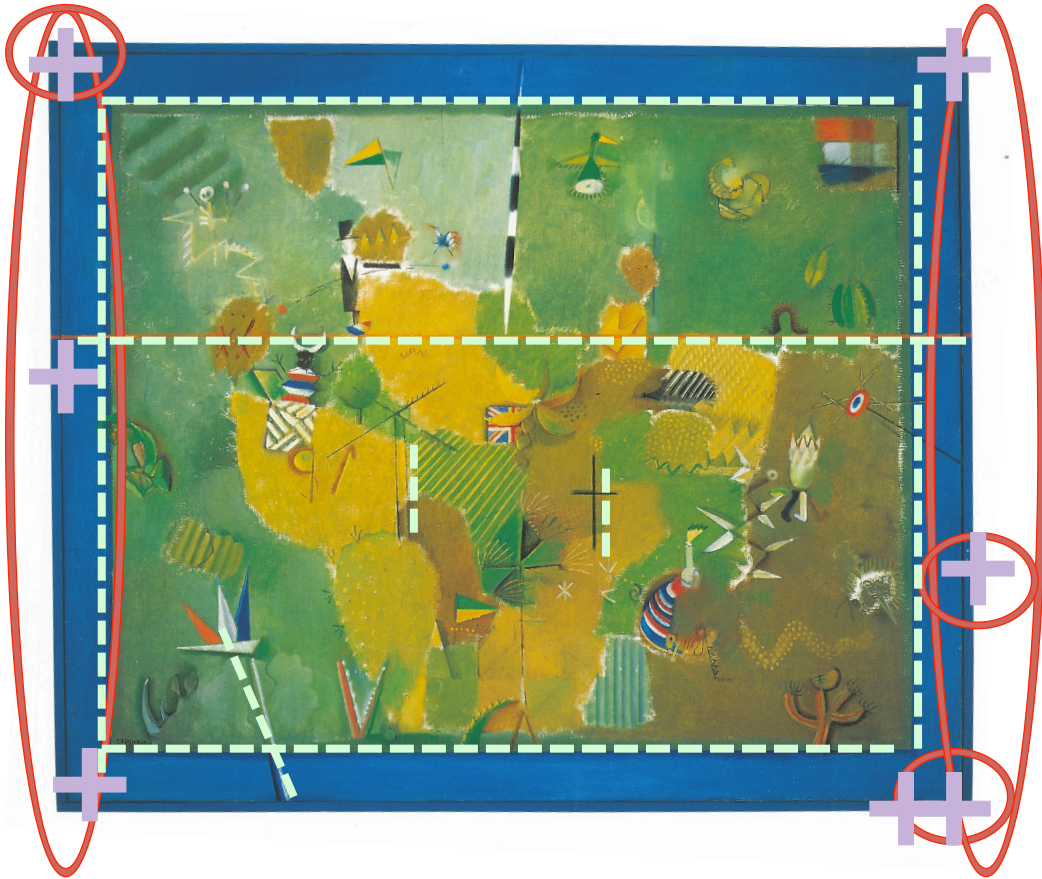
Frame Damage

Masking tape damage

Frame damage

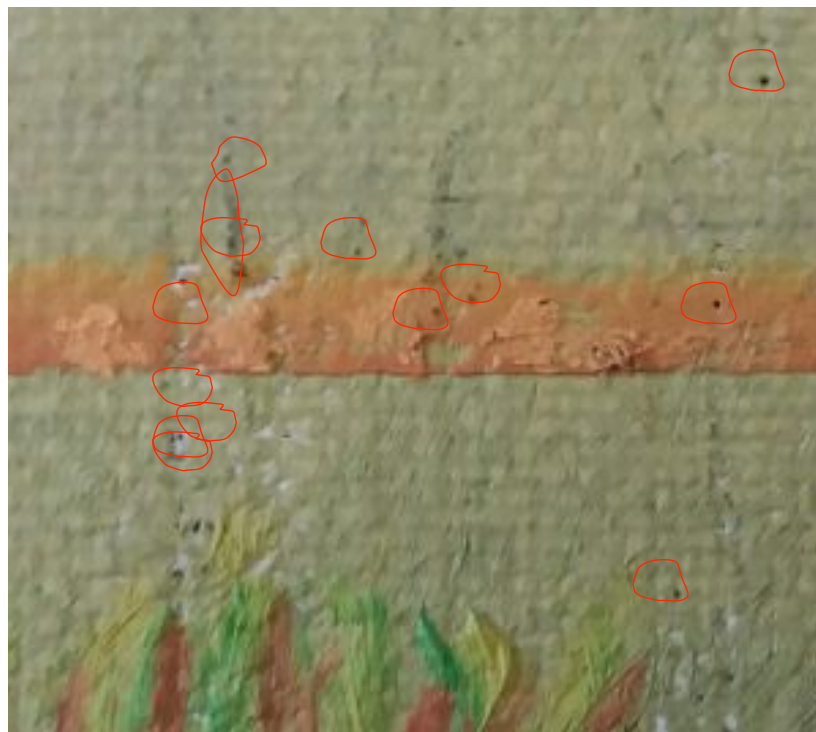
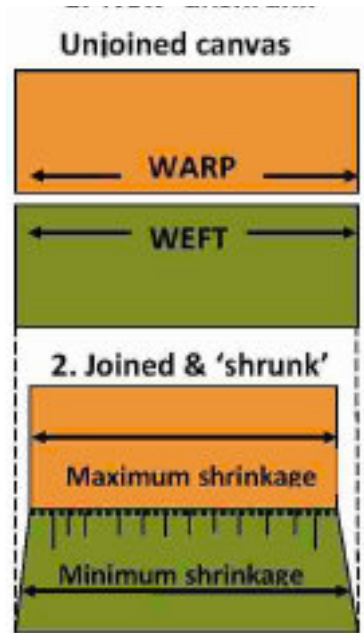
Close up highlighting some areas of the painting and the shrinking affects

Therefore hinder the canvas capability to preserve the fiber's flexibility and stops the canvas from going brittle. Thus because unlike linen cotton is not regarded as having a more 'natural' weaved finish. Pinker's prime layer is in fact the green layer that we see therefore the canvas has not had the ability to fully return back to its relaxed fiber dimension but is not instead returning to that.

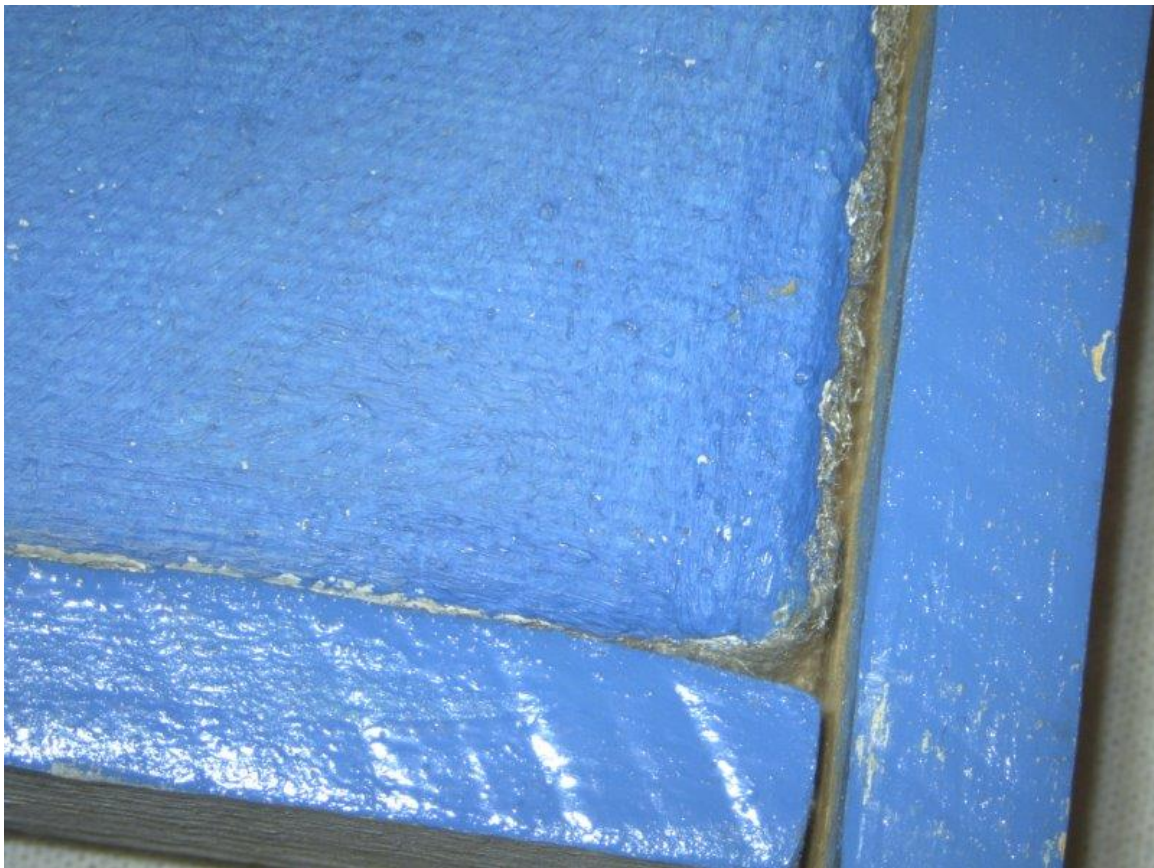
Close up highlighting paint loss

The dust that has been gathering throughout the frame in pinkers work highlights how dust when hydroscopic can ultimately cause paint loss

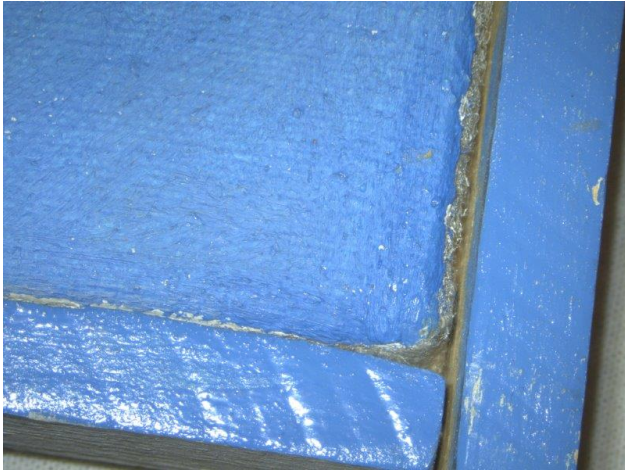
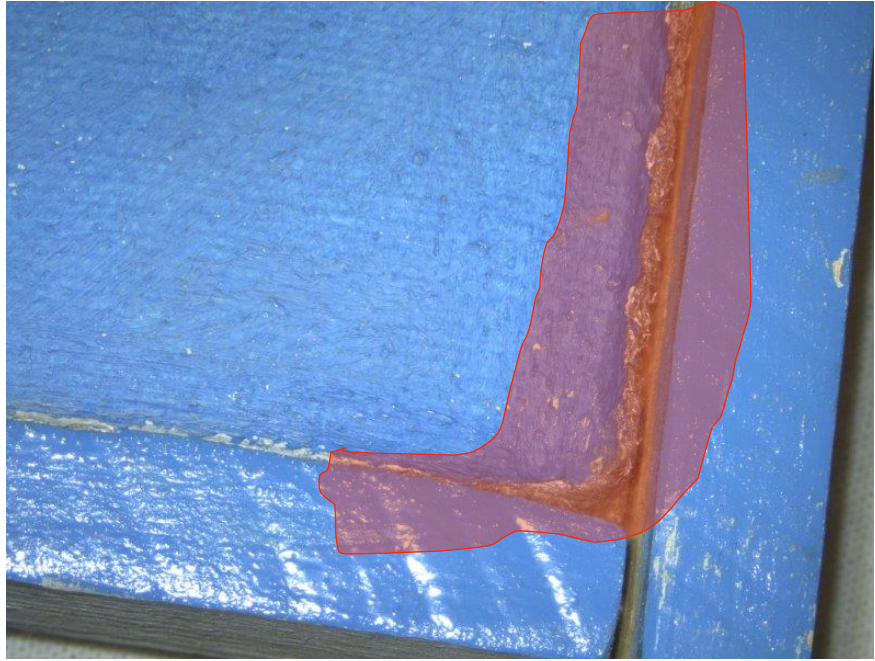
This can also be because the paint used for the frame and the paint used for the painting differ therefore one can argue that the inpainting at the points where the canvas and paint met has caused this.

Due to Pinkers quest to produce everything by himself the mitre joint has not been connected properly causing a dent at the bottom left of the painting. **Therefore making the bottom left corner of the painting pressure sensitive due to the trauma that may have occurred.**

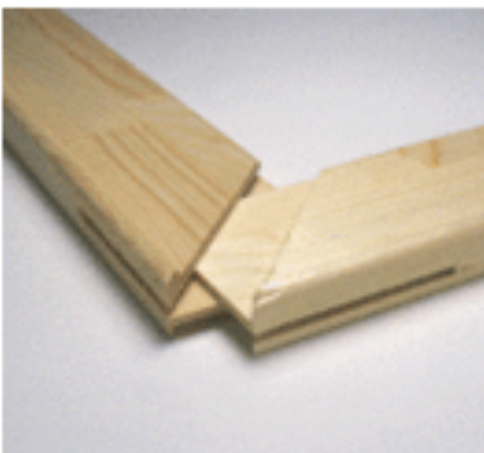
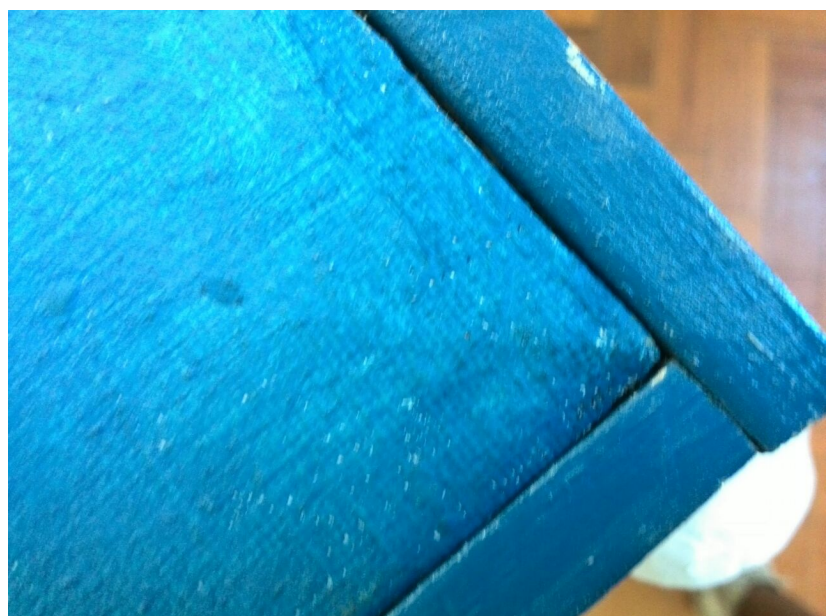
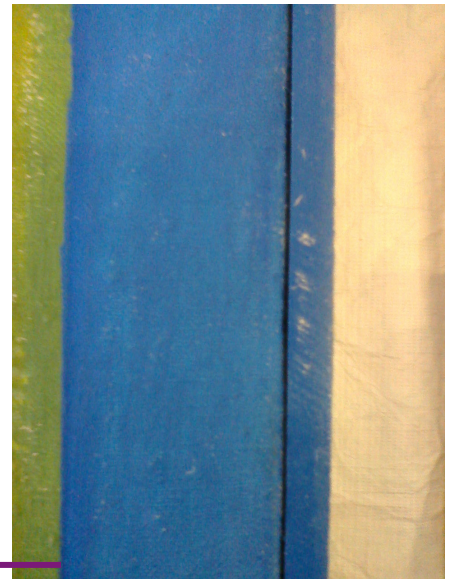
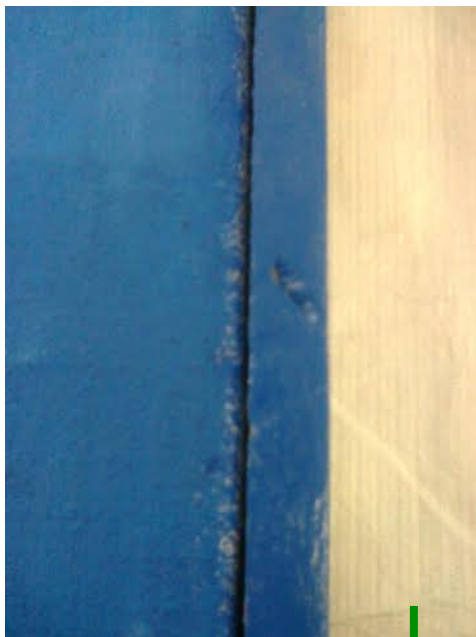
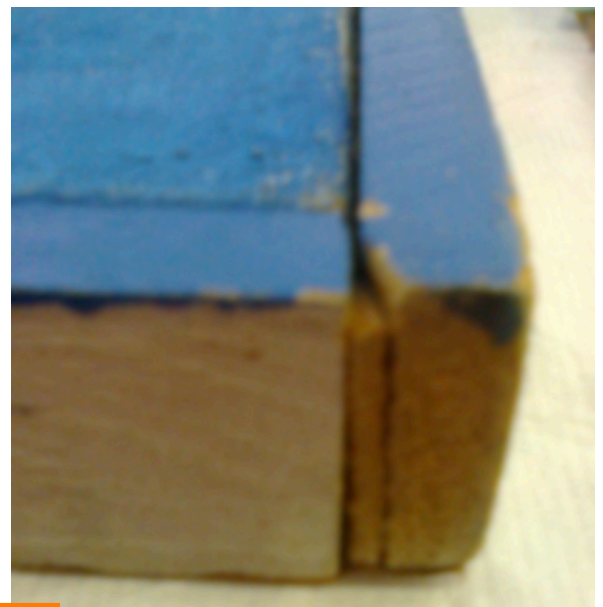
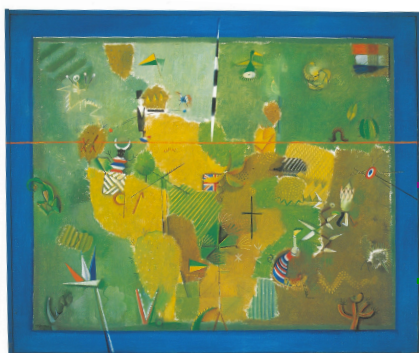
There are a number of different places where the frame has encountered losses as identified by the images. All of these sites of losses all occur at on the right hand side of the painting therefore indicating that either the painting was mishandelled and collapsed on its right hand side. (Indicated in the diagram)

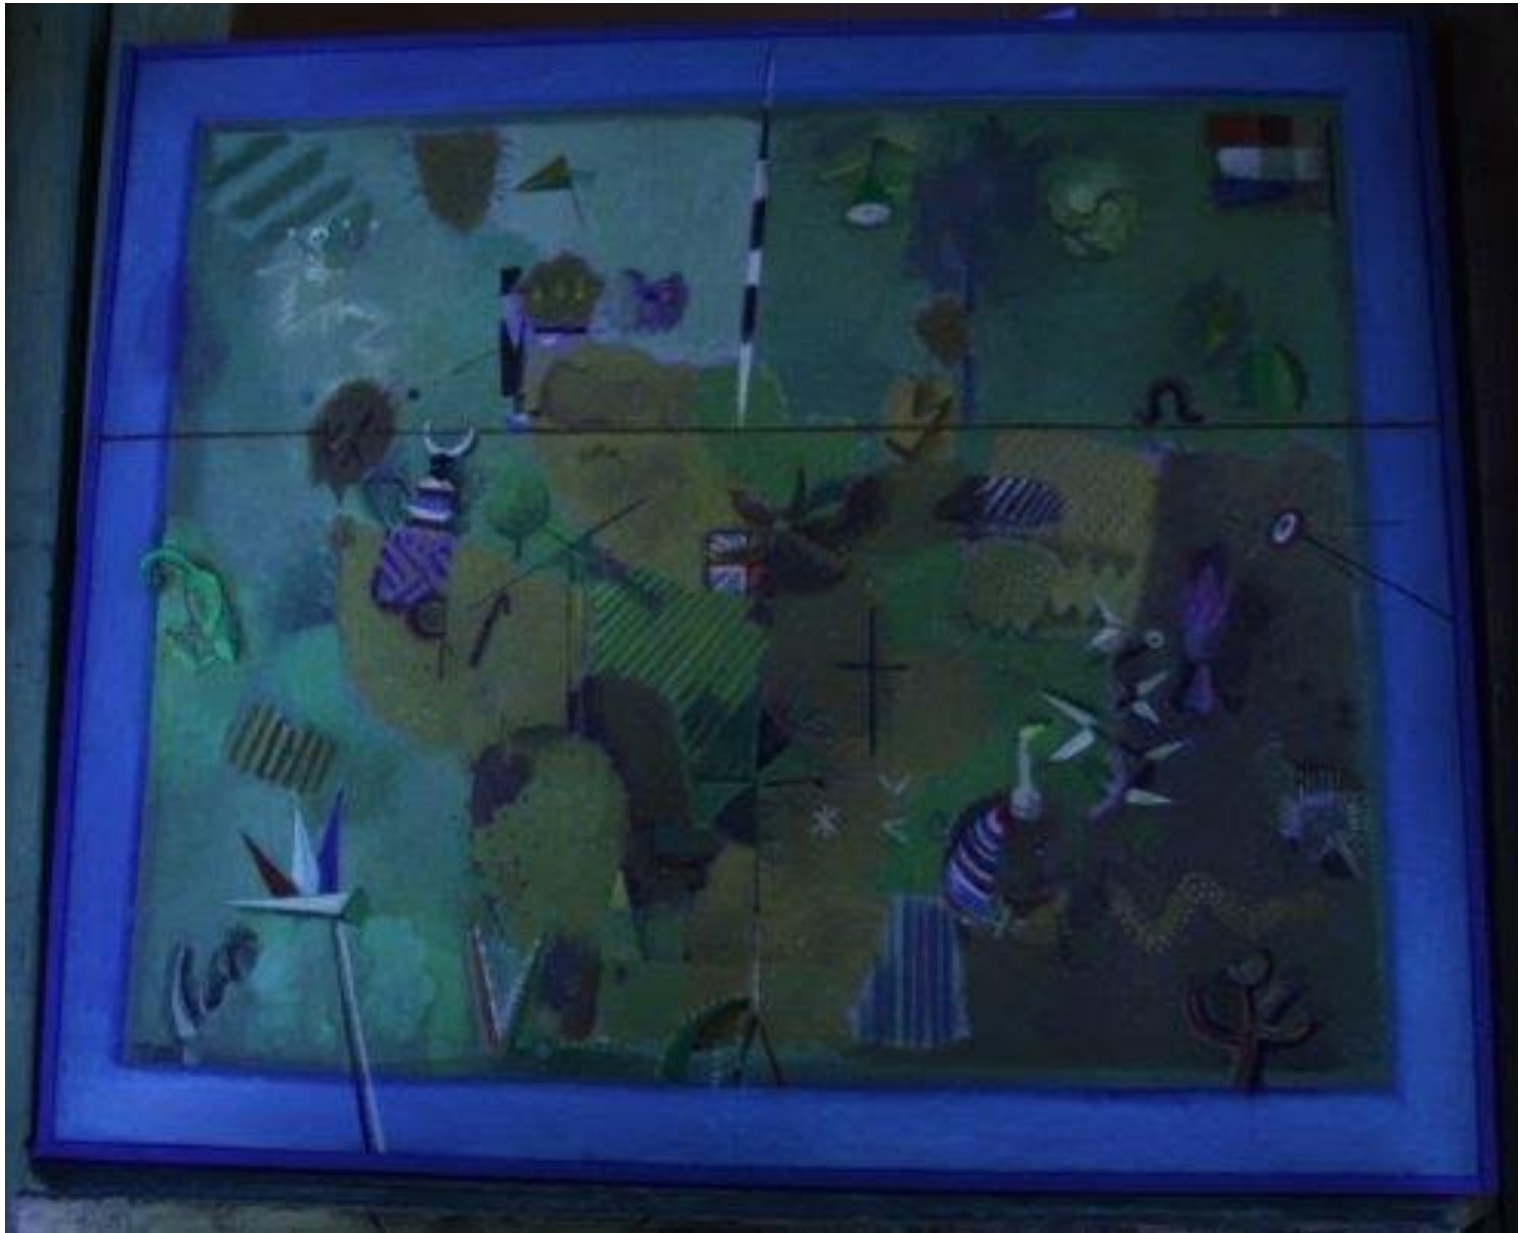
Whole front, ultra violet light

Thus one can determine by looking at Pinker's work that the light that is reelected black especially in what appears to be the boarder of of the painting which is reflected back to us as the fluroscene appears to be added later onto the image.

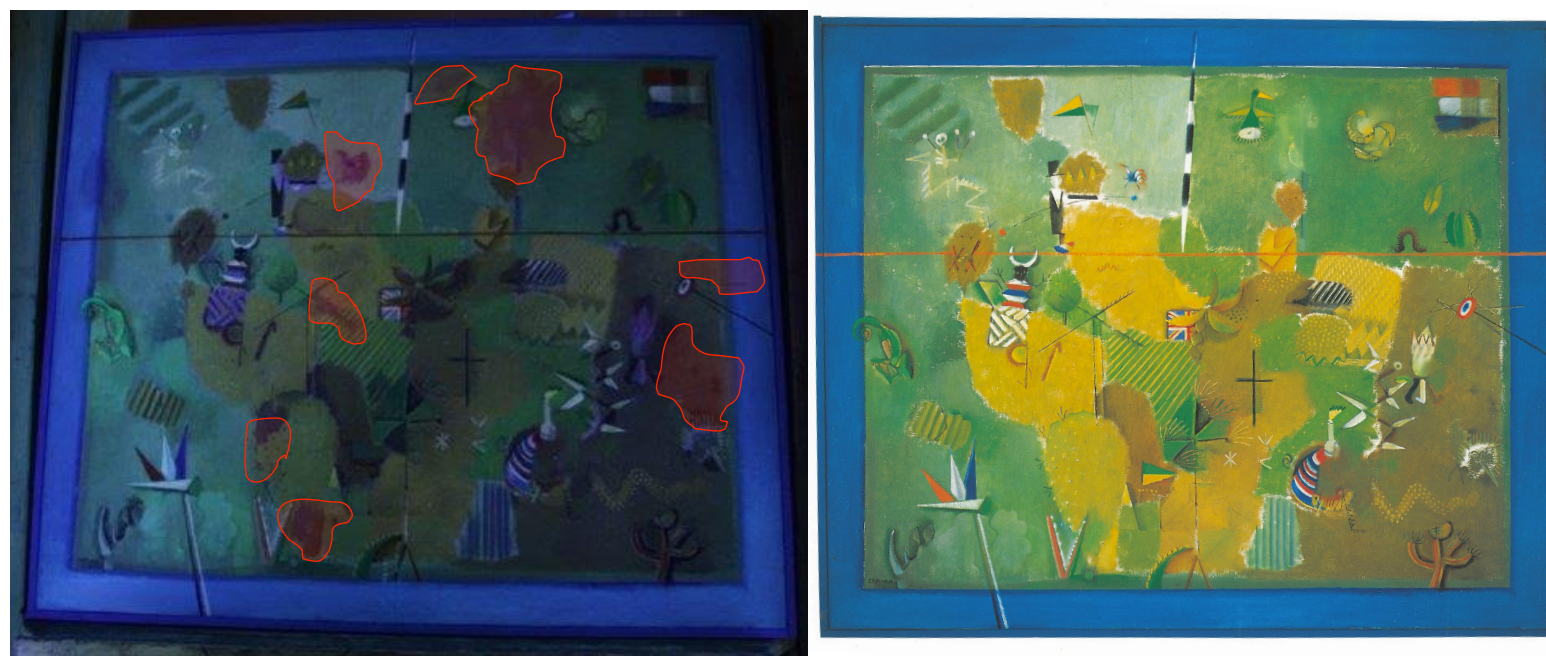
In other areas of the painting one can observe that the artist later when to review the artwork which is again supported by the varying degrees of paint that appears in the artwork. When one looks at what is now known as *Artist on a tightrope in a prickly landscape* mabe the unpainted layer was infact *Prickly landscape with the artist poised for a fall.*

Juxtaposition of images highlighting composition alteration by the artist
