UNIVERSITY OF CAPE TOWN

# Conservation Report

Dorothy Kay, The Lamp (1954)

## CONSERVATION REPORT

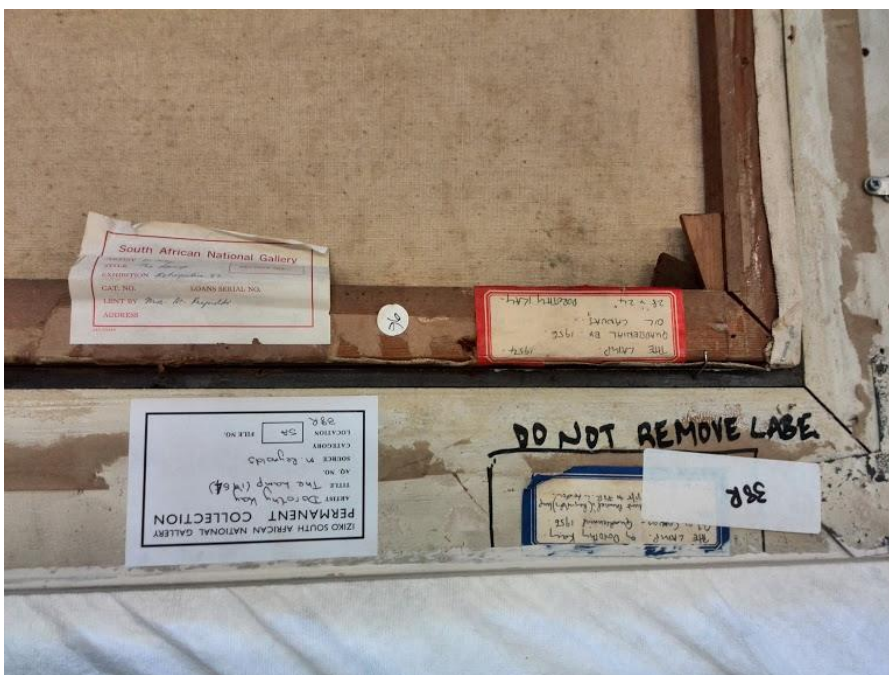
1. "Iziko South African National Gallery  
Permanent Collection  
Dorothy Kay, *The Lamp* (1954)  
Source: M. Reynolds  
Location: SA  
File no.: 38R"
2. "*The Lamp* by Dorothy Kay, 1954  
Oil on canvas – Quadriennial 1956  
Aunt Muriel's (Reynolds) Lamp"
3. "38R"

Labels on frame and secondary support.

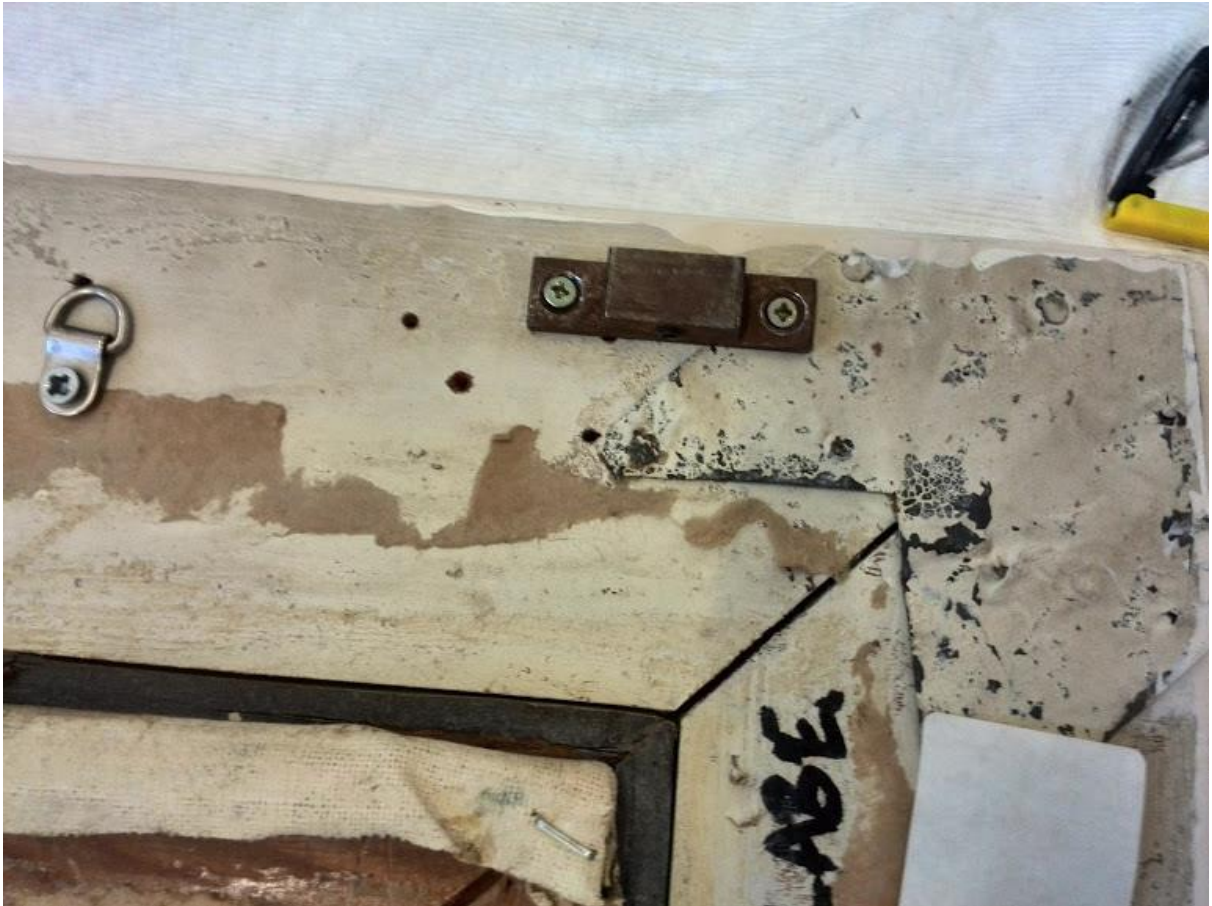
The frame is in good condition with light dirt marks on the front. On the back the corners of the frame are fixed with metal V-shaped plates. There are various places where screws and nails had been removed from the frame. Brown gum tape had also been removed partially from the back but some pieces have not been fully removed. There are three labels stuck to the top member of the frame and around it in black marker is written "do not remove label." The labels read:

Back of frame showing metal corner-support and hanging-fittings, as well as evidence of previous nail holes and gum tape that had been removed.

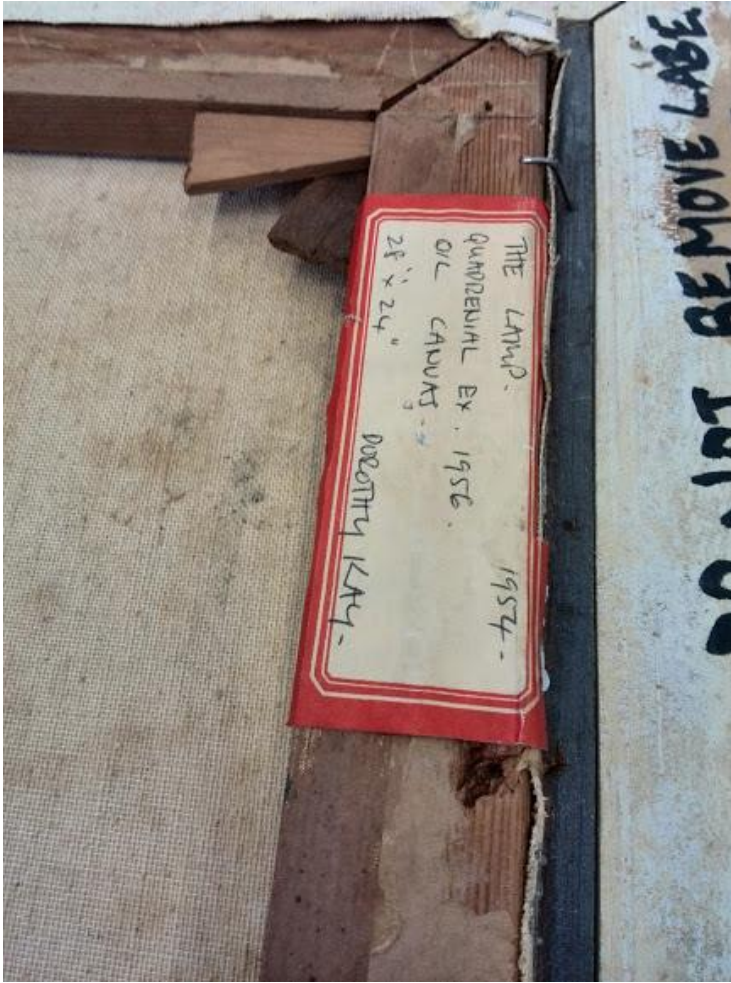
The canvas is supported by a wooden stretcher, comprising of four members. Their dimensions are 39mm in width and 18mm at the beveled edge facing the inside of the canvas. The members are put together with a mortise and tenon joint. There are eight wooden expansion keys; two in each joint. The secondary support is in an overall good condition. There are two labels and a sticker stuck onto the support:

Image showing top left corner of the wooden secondary support, label, mortise and tenon joint as well as expansion keys.

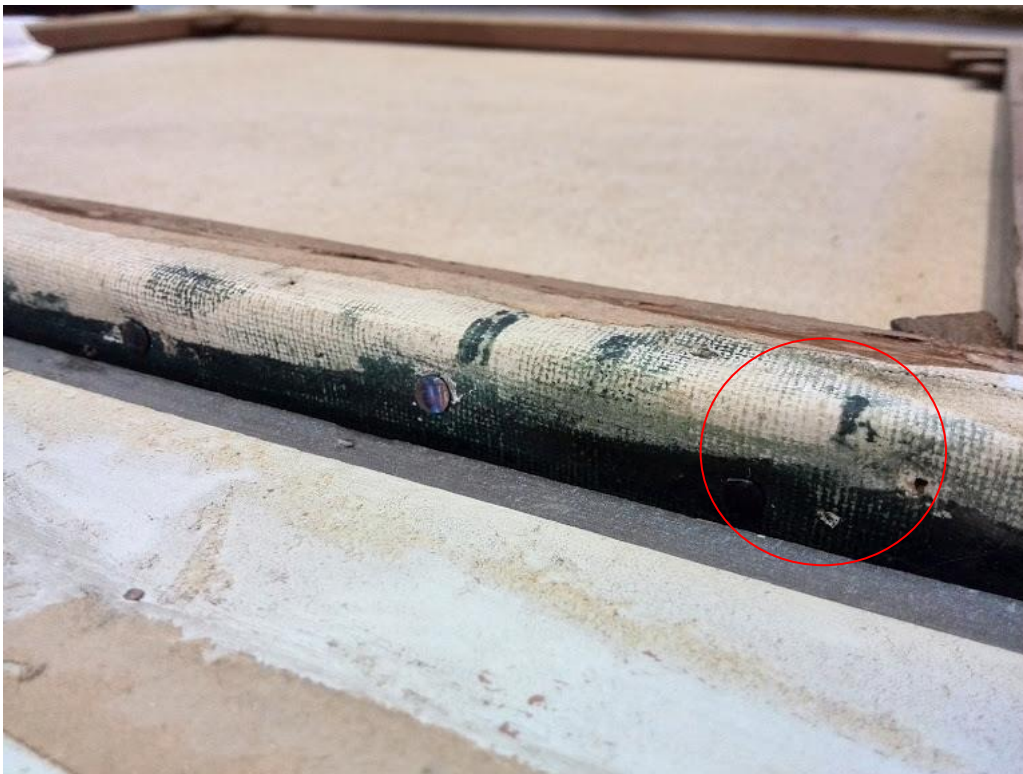
One can speculate that this is not the original support. This may be due to the previous support creating stretchy bar line marks due to not having a beveled inner. This current support is beveled. Evidence for a previous support can be drawn from holes from previous nails attaching the canvas to the support. The canvas is also not evenly stretched around the support and shows paint extending over two sides of the canvas.

Holes where previous nails had attached canvas to secondary support.

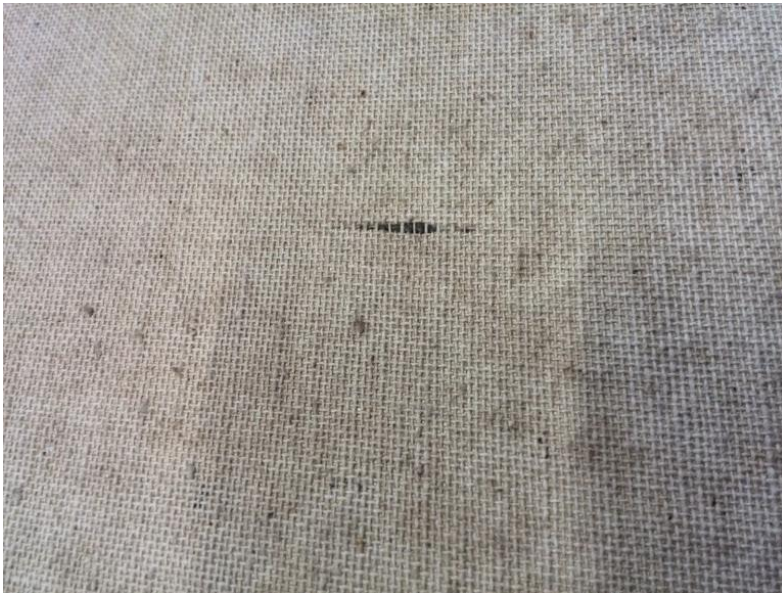
The canvas is in a general good condition with only one tiny slub in the top right corner. There is one surface deformation visible when one views the front of the canvas. There is a small dent, possibly due to dirt trapped between the canvas and the secondary support. The canvas is slightly discoloured with a few dirt marks.

Minor slub in back of canvas.

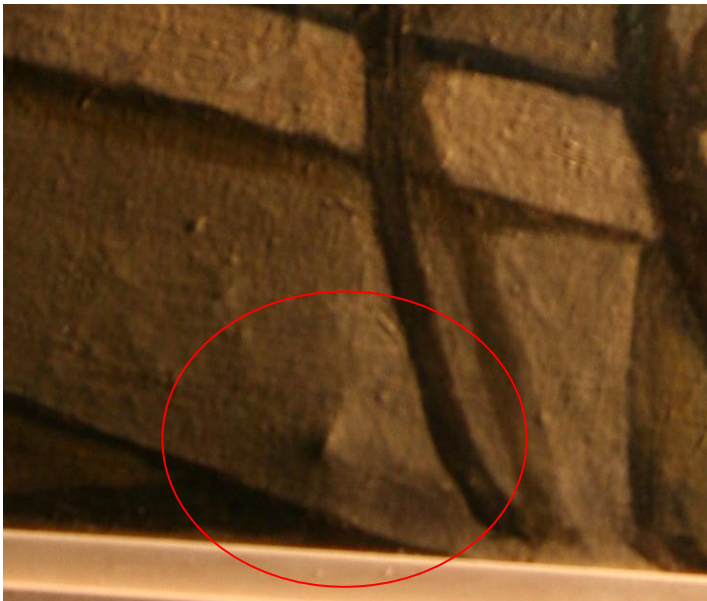
Small dent at the bottom middle of the canvas.

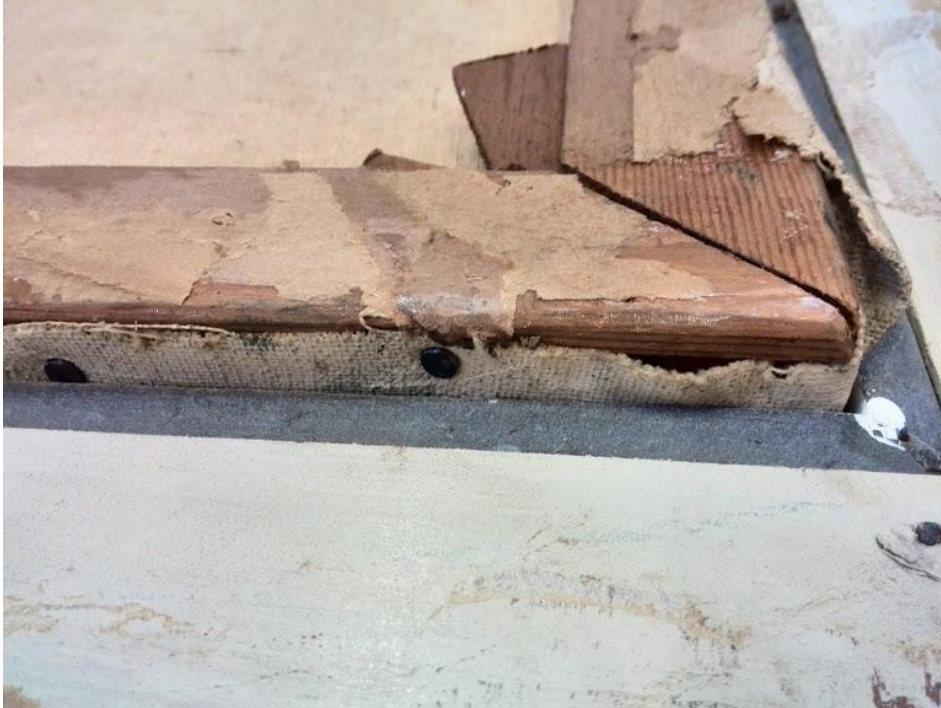
The ground appears to be durable and in good condition. The raking photograph reveals a white-coloured ground under the light layers of the painting, in the background behind the neck of the lamp. A black imprimatura is applied over the bottom third of the ground before the artist started her final paint layer. At the back of the canvas one can see the extent of the ground going over the edge of the canvas, indicating a commercially prepared canvas. The ground is gesso.

Ground extends beyond edge of painting.

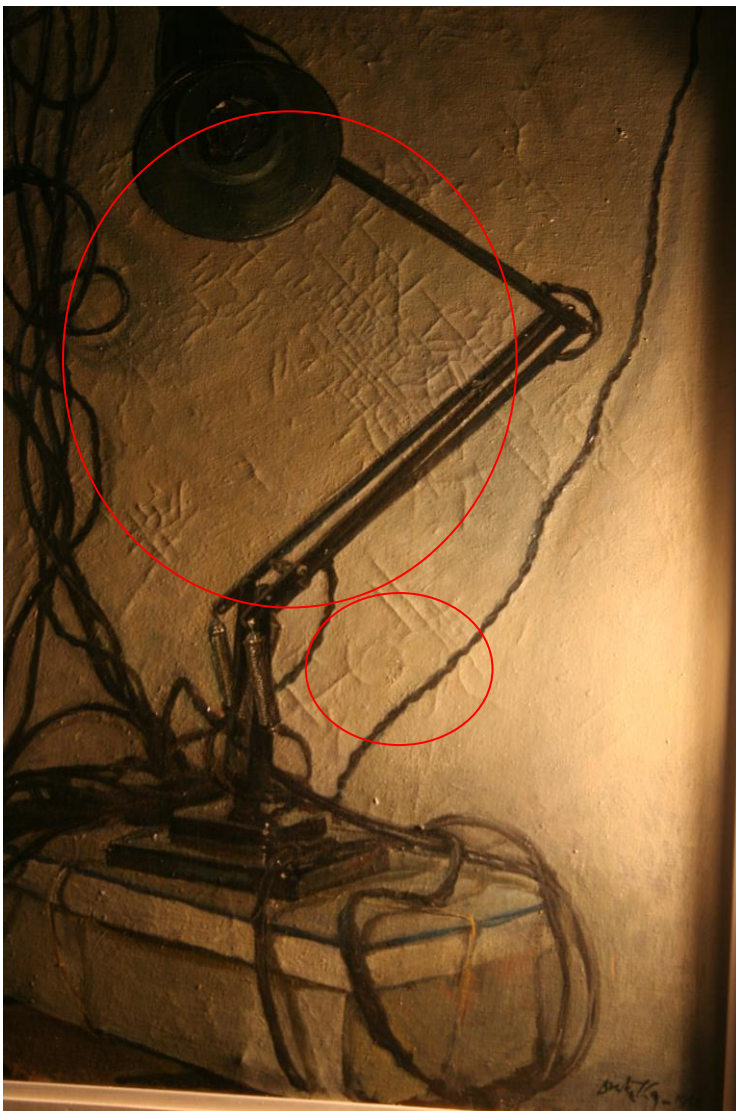
Large areas of the painting are covered by aging cracks. Under scrutiny of the raking light and magnification one can also see a small sigmoid crack between the single chord and the first bend of the lamp. Small scratch marks appear on the front edge of the box's lid. There is also a miniscule orange dot of paint to the right of the lamp's head. There are visible stretch marks along all four sides of the canvas, possibly caused by the previous unbeveled secondary support.

Aging cracks (big circle) and sigmoid crack (small circle) under raking light.

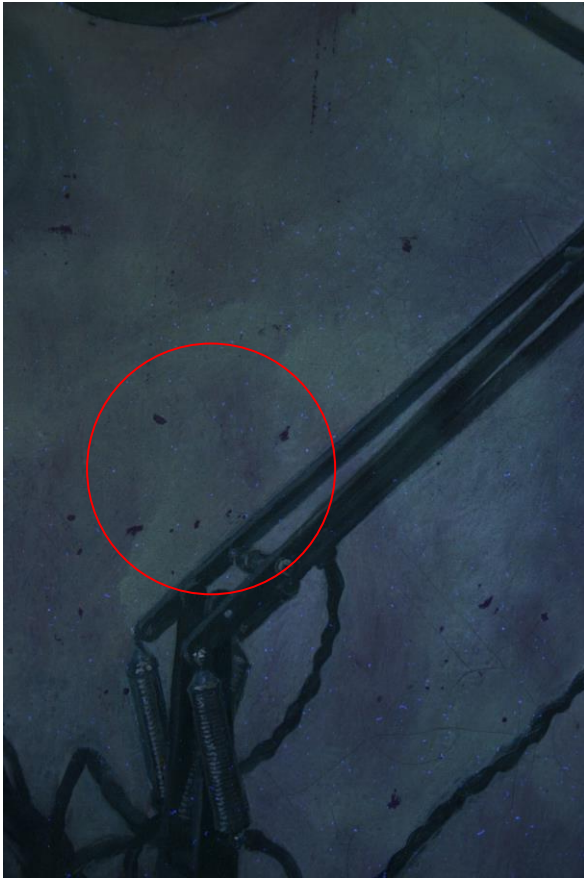
UV light reveals small black marks on various areas of the painting, indicating minor touch-up restoration. When examined under the raking light one can see a thicker texture where the paint was applied.

Small black marks indicating minor touch-ups.

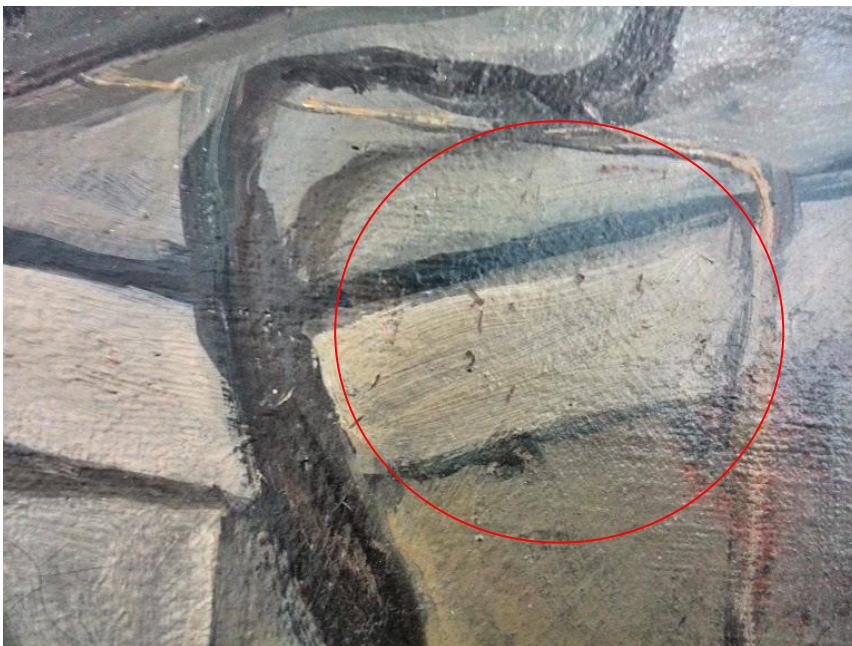
Small scratch marks.

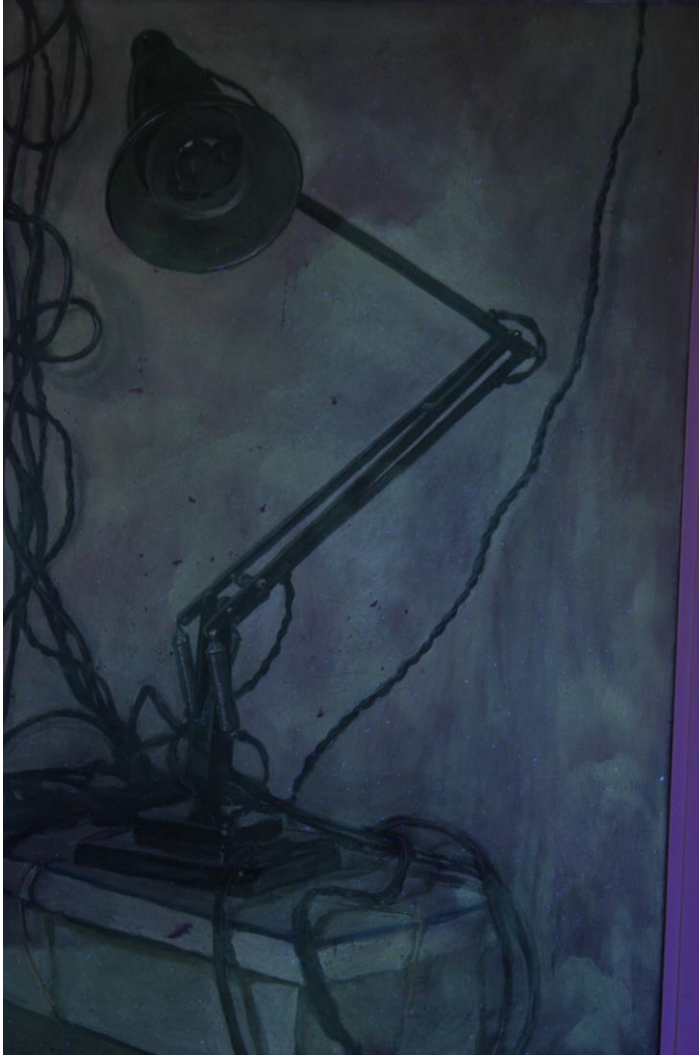
UV light reveals irregular varnishing across the surface of the painting. It may possibly be that the painting was not varnished by the artist. The UV light shows varnish that is thicker and drippier in some areas and is painted over most of the painting. It also shows areas where varnish was painted over a few times. The varnish shows green under the UV light, indicating a natural varnish.

Varnish showing light green and irregular under UV light.
