CONDITION REPORT  
IDENTIFICATION DETAILS

Edward Wolfe  
1897 - 1982

Aishia  
Portrait of a women.

Elize de Beer  
2016

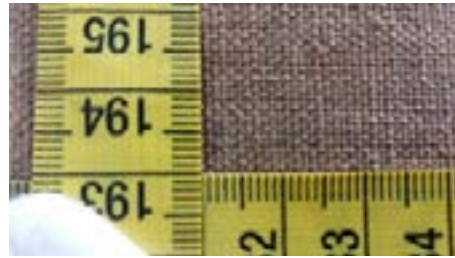
The overall condition is good, one piece of canvas has been used and there seems to be no previous restorations made to the support. The canvas is strong and taught within the secondary support structure, with little embrittlement and degradation.

There are no tears or serious damage to the front of the support other than tack holes that run along the left side of the painting that can be seen through raking light. Bucking isn't immediately visible however when put under racking light, bucking can be seen caused by a stretch bar mark along the left side of the painted canvas.

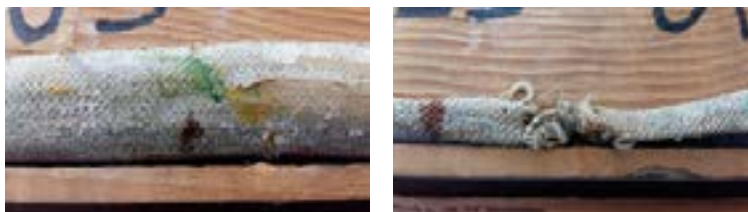
At the back of the painting the canvas is fraying at the edges, there is a tear that carries into the member in the top middle, and there are also visible tack marks from a presumable original stretcher.

The canvas is attached using tacks which are not in good condition and are rusting. They are evenly spaced, 70mm apart. The tacking margin is in good order with an average width of 15mm. The tacks marks and margin have been covered by extra wooden supports that run along the sides of the painting. I assume that it was done to hide the tack marks for aesthetic reasons.

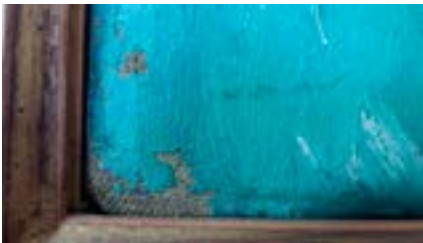
The ground and paint surface has suffered from surface abrasions on the two bottom corners and along the tack hole marks along the left side on the painting, where raw canvas is now exposed and there are no signs of restoration.

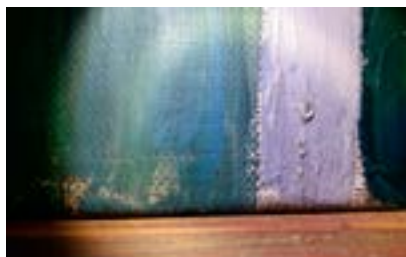
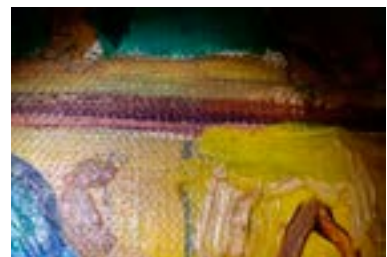
Wolfe painted in impasto and because of the strong brushstroke mark lines, there are pieces of exposed ground that are visible between these brushstroke lines and the extended canvas as a result of stretching at the back of the stretcher.

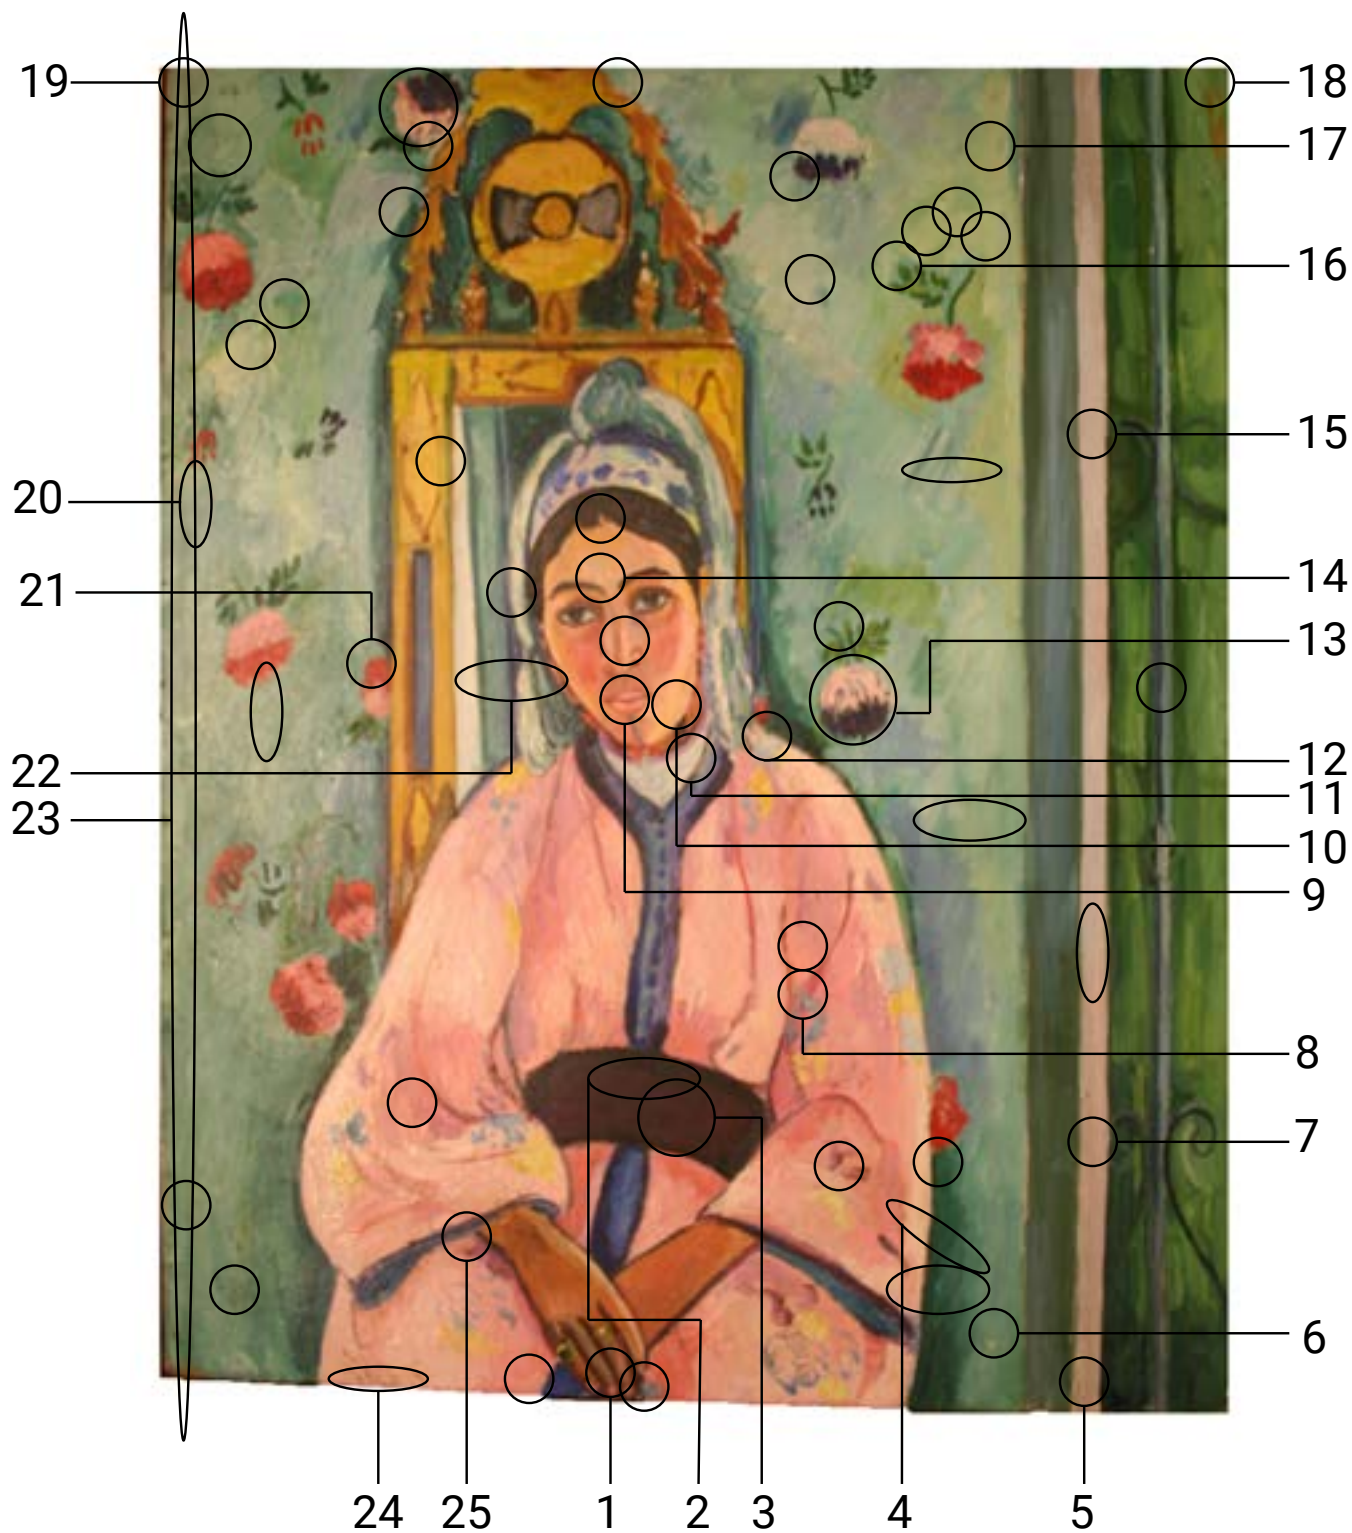
Even though it is a young painting, only 78, it has a large amount of cracks throughout.

These are the most predominate cracks in the painting regardless of paint consistence.

These cracks penetrate though the ground to the paint layer.

Refer to Crack Figures 1; 5-21; 24-26.

There is a fish tail crack which is caused by a firm markers pressing onto the back on the canvas that has left the crack behind. Refer to Crack Figure 4. When looking at the area in Raking Light, it shows how something pressed against the back of the canvas causing the cracks and how it has left a dent in the canvas.

Along the left side of the painting is a crack running from top to bottom 20mm from the edge of the painting. A stretcher would create this type of crack and when the painting was removed from the stretcher this crack would remain. This gives evidence to that fact that it is now not in its original secondary support structure. Refer to Crack Figure 22. It can also be seen clearly though racking light.

Also known as traction crack, this is caused by layers of paint or varnishing painted over partially dried oil paint. The only drying cracks are within the woman's sash around her waist. Refer to Crack Figure 2-3.

There is a large amount of cracks for such a young painting. The painting travelled from Morocco to England and to South Africa where it now resides. This long distance traveling may have been the root of its mishandling, vibrations from transportation, and the flux in humidity and light conditions of the painting could be the causes of the various cracks.

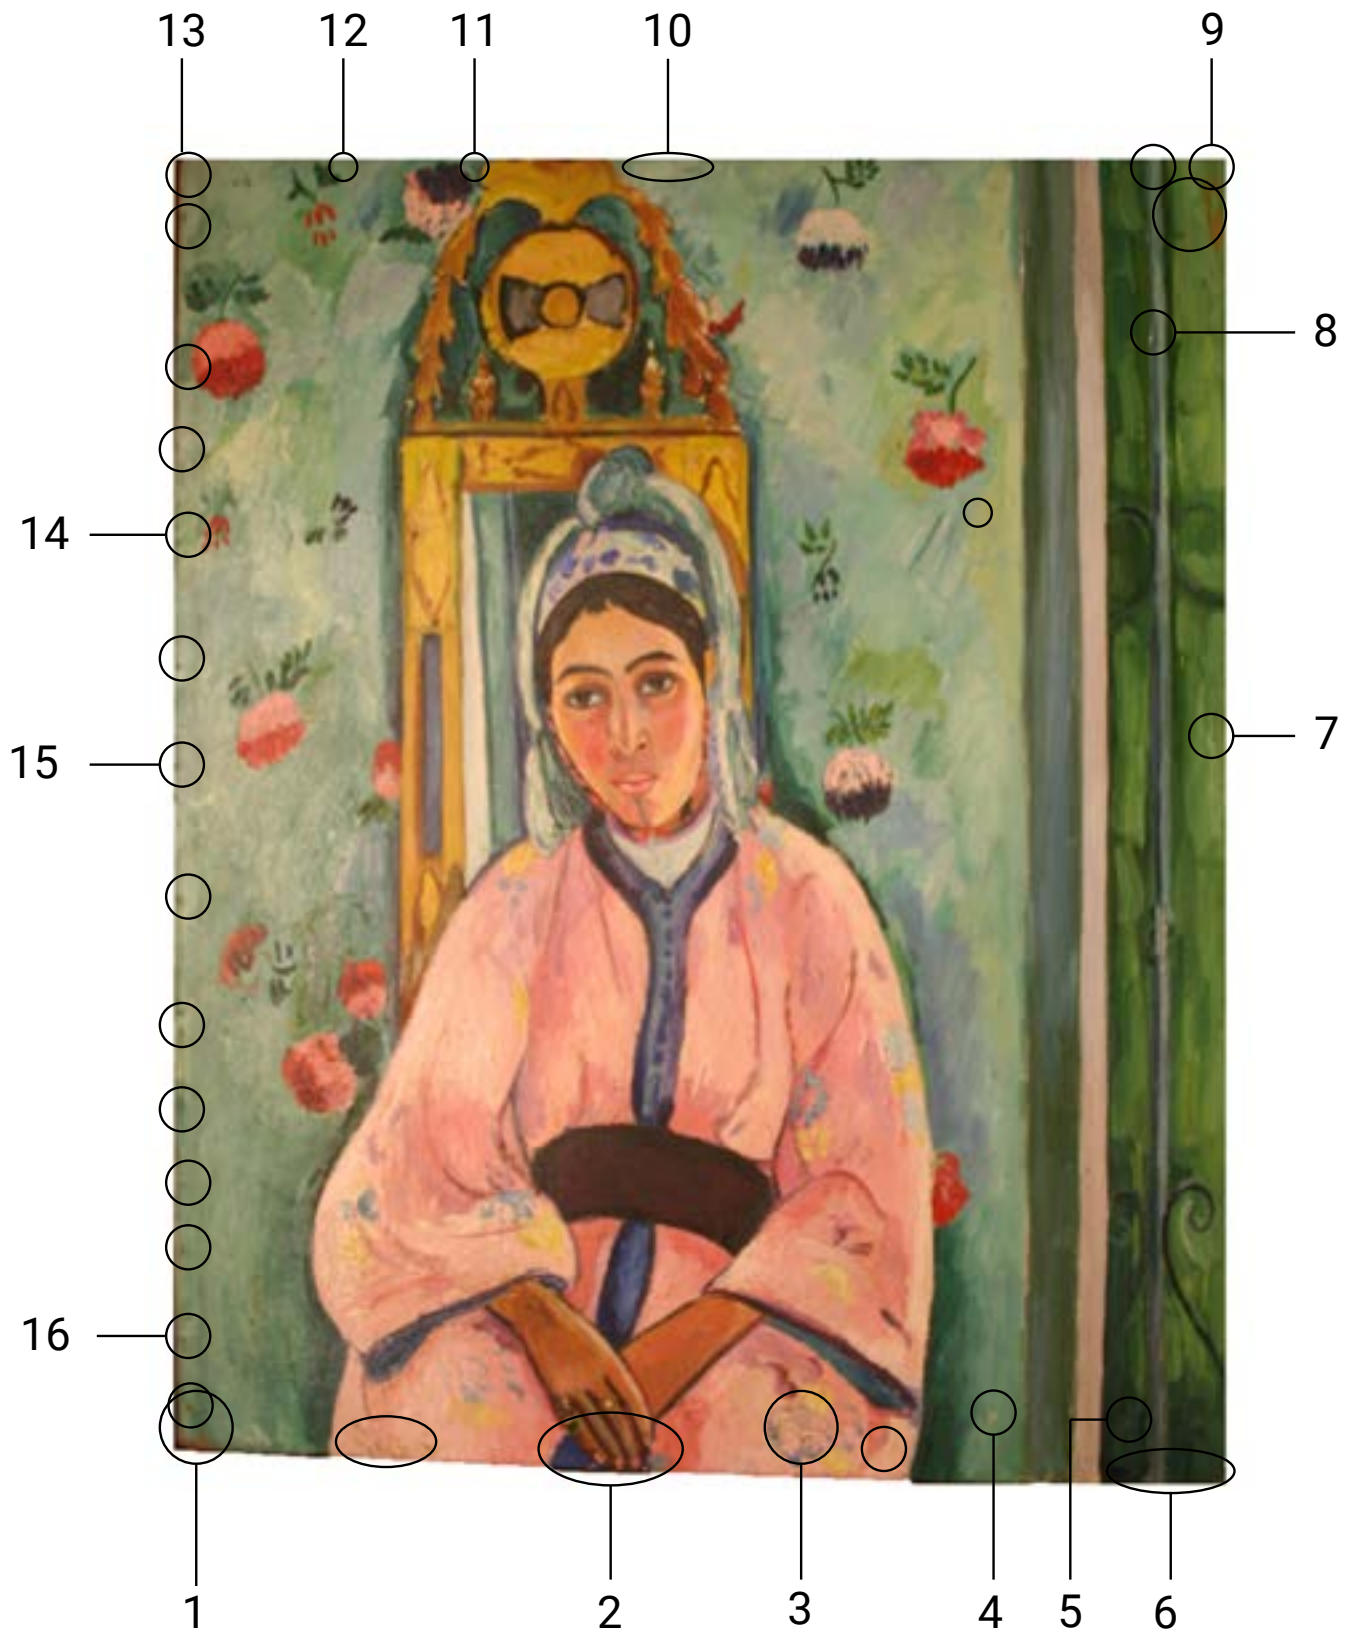
There are chips, and paint abrasion mostly on the edges of the painting that range in size. This might be due to the fact that the painting has been mishandled when being put within the secondary support and again within the frame. It could also be caused by general mishandling and disregard for the painting. Refer to Chip and Abrasions Figures.

Scratches in the paint layer show how the painting has been mishandled. Refer to Chip and Abrasions Figures 7 and 12. The loss of paint and ground has also been a cause of the compromise of the primary support. This compromise has been caused by the tack holes that run along the left side of the painting. The holes have caused the paint and ground around them to fade. Over time if not repaired the paint loss will increase in those areas. This applies to all chips and abrasions.

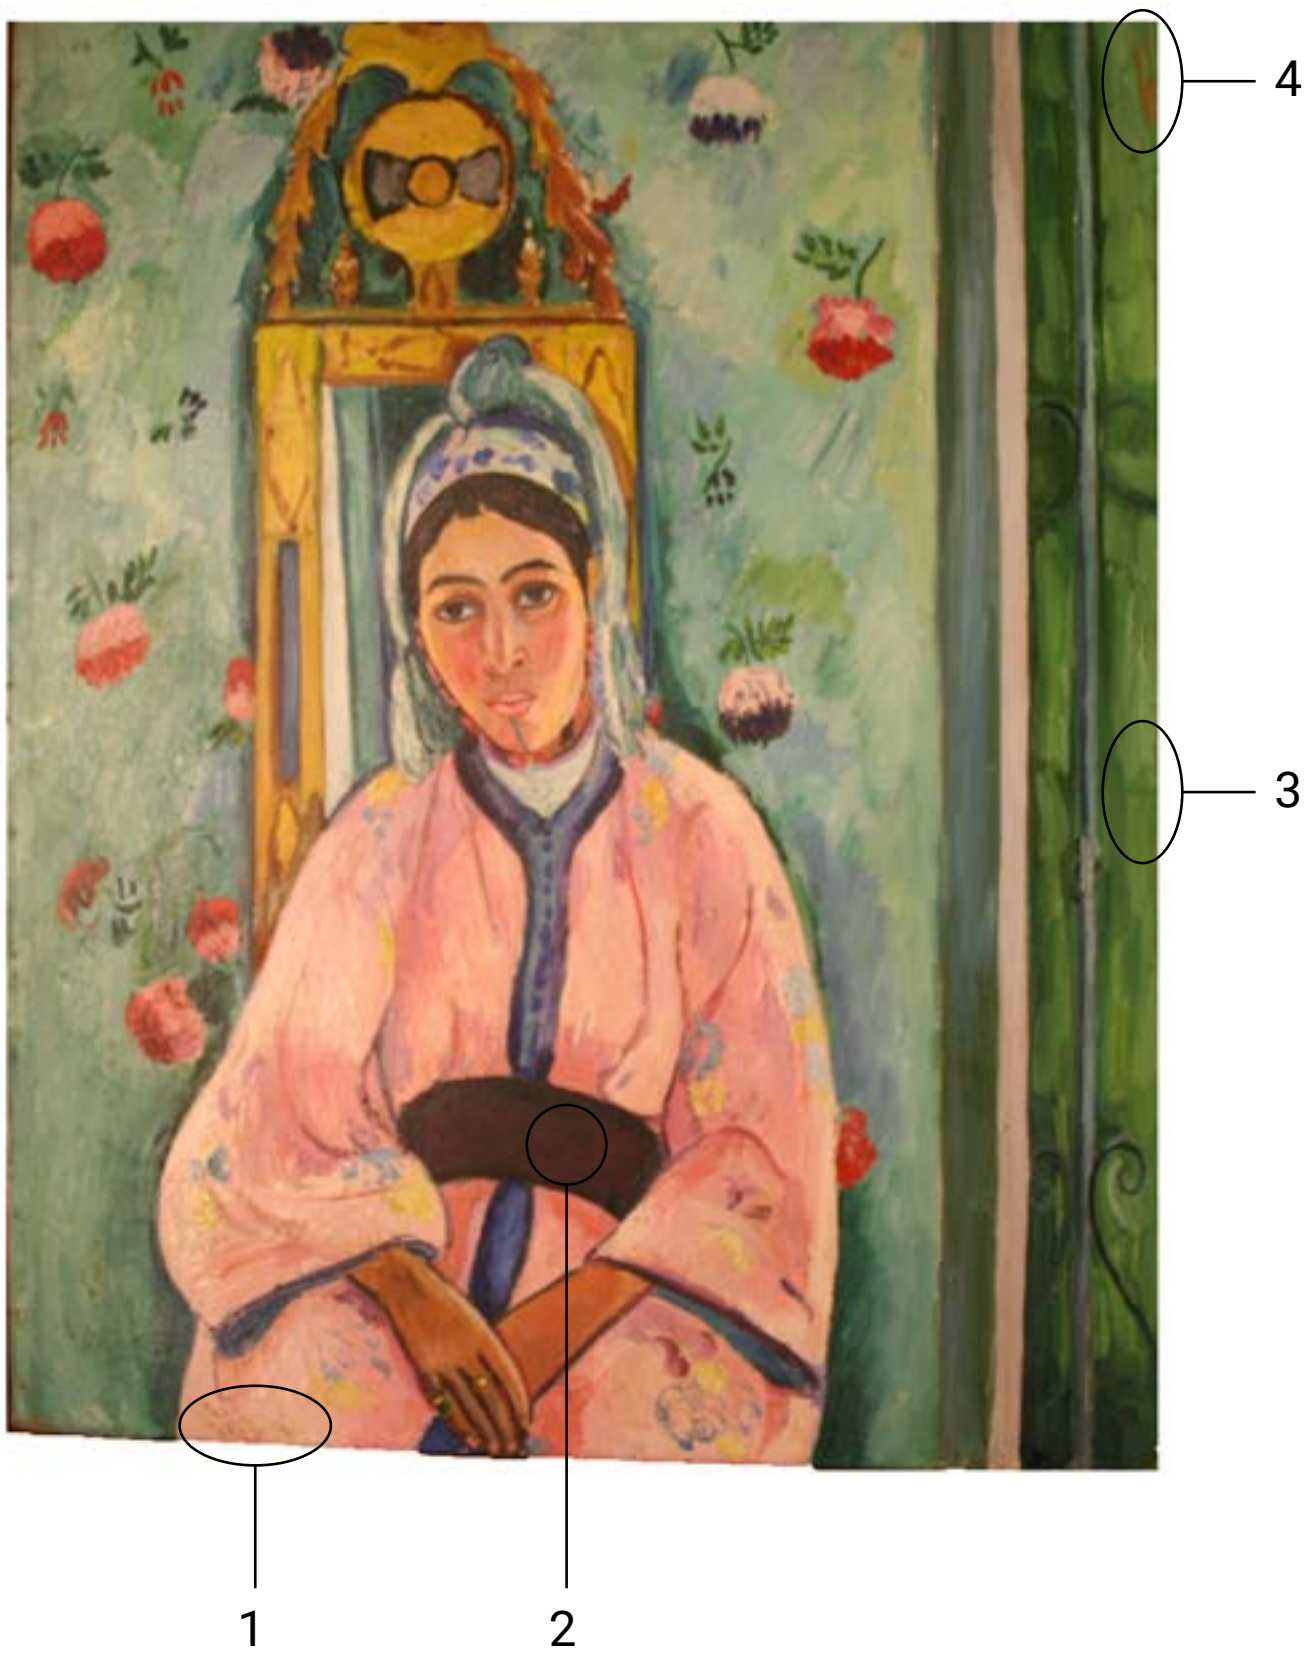
At the bottom of the painting there is some dirt accretion. It seems to be a splash of adhesive or sticky residue that has stuck to the painting and has then kept collecting. Painted Surface Figure 1.

Since Wolfe painted in impasto the pronounced brushworks have the potential of trapping dirt and dust in the groves of the paint if the painting is not looked after properly. There is brown gum trap residue along the top right of the painting and in the middle. – adding evidence that this is not the paintings original secondary support. Refer to Painted Surface Figure 3-4.

There are two small hairs in the sash of the women's cloths. It is hard to locate at first because of how thick Wolfe's paint layers were and in relation to the drying cracks that surround it. Figure 2.

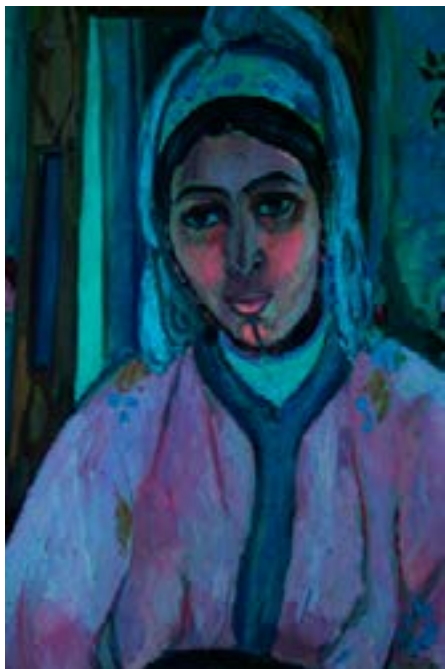
There appears to be no varnish used. The Green shades that are visible are there due to the green pigments Wolfe used. However there are some areas in the painting where the green appears more florescent than others, which may just be the type of pigment or may indicate selective varnish application to give that particular area more sheen. When looking at the painting with raking light, there are some areas that have a greater sheen than others, which could indicate varnish.

UV light can also be used to tentatively identify certain pigments depending on their auto-fluorescent properties, which can also be seen. In the painting we can see that this applies to the florescent pink that appears on her cheeks and chin in-between a blue vertical line on her chin. The Pigment Rose Madder florescent nature creates a glow in the women's face. The pigment is not used anywhere else on the painting. We can then assume that the colour was carefully chosen for her face, separating it from the back ground and her clothes as the focal point of the painting.

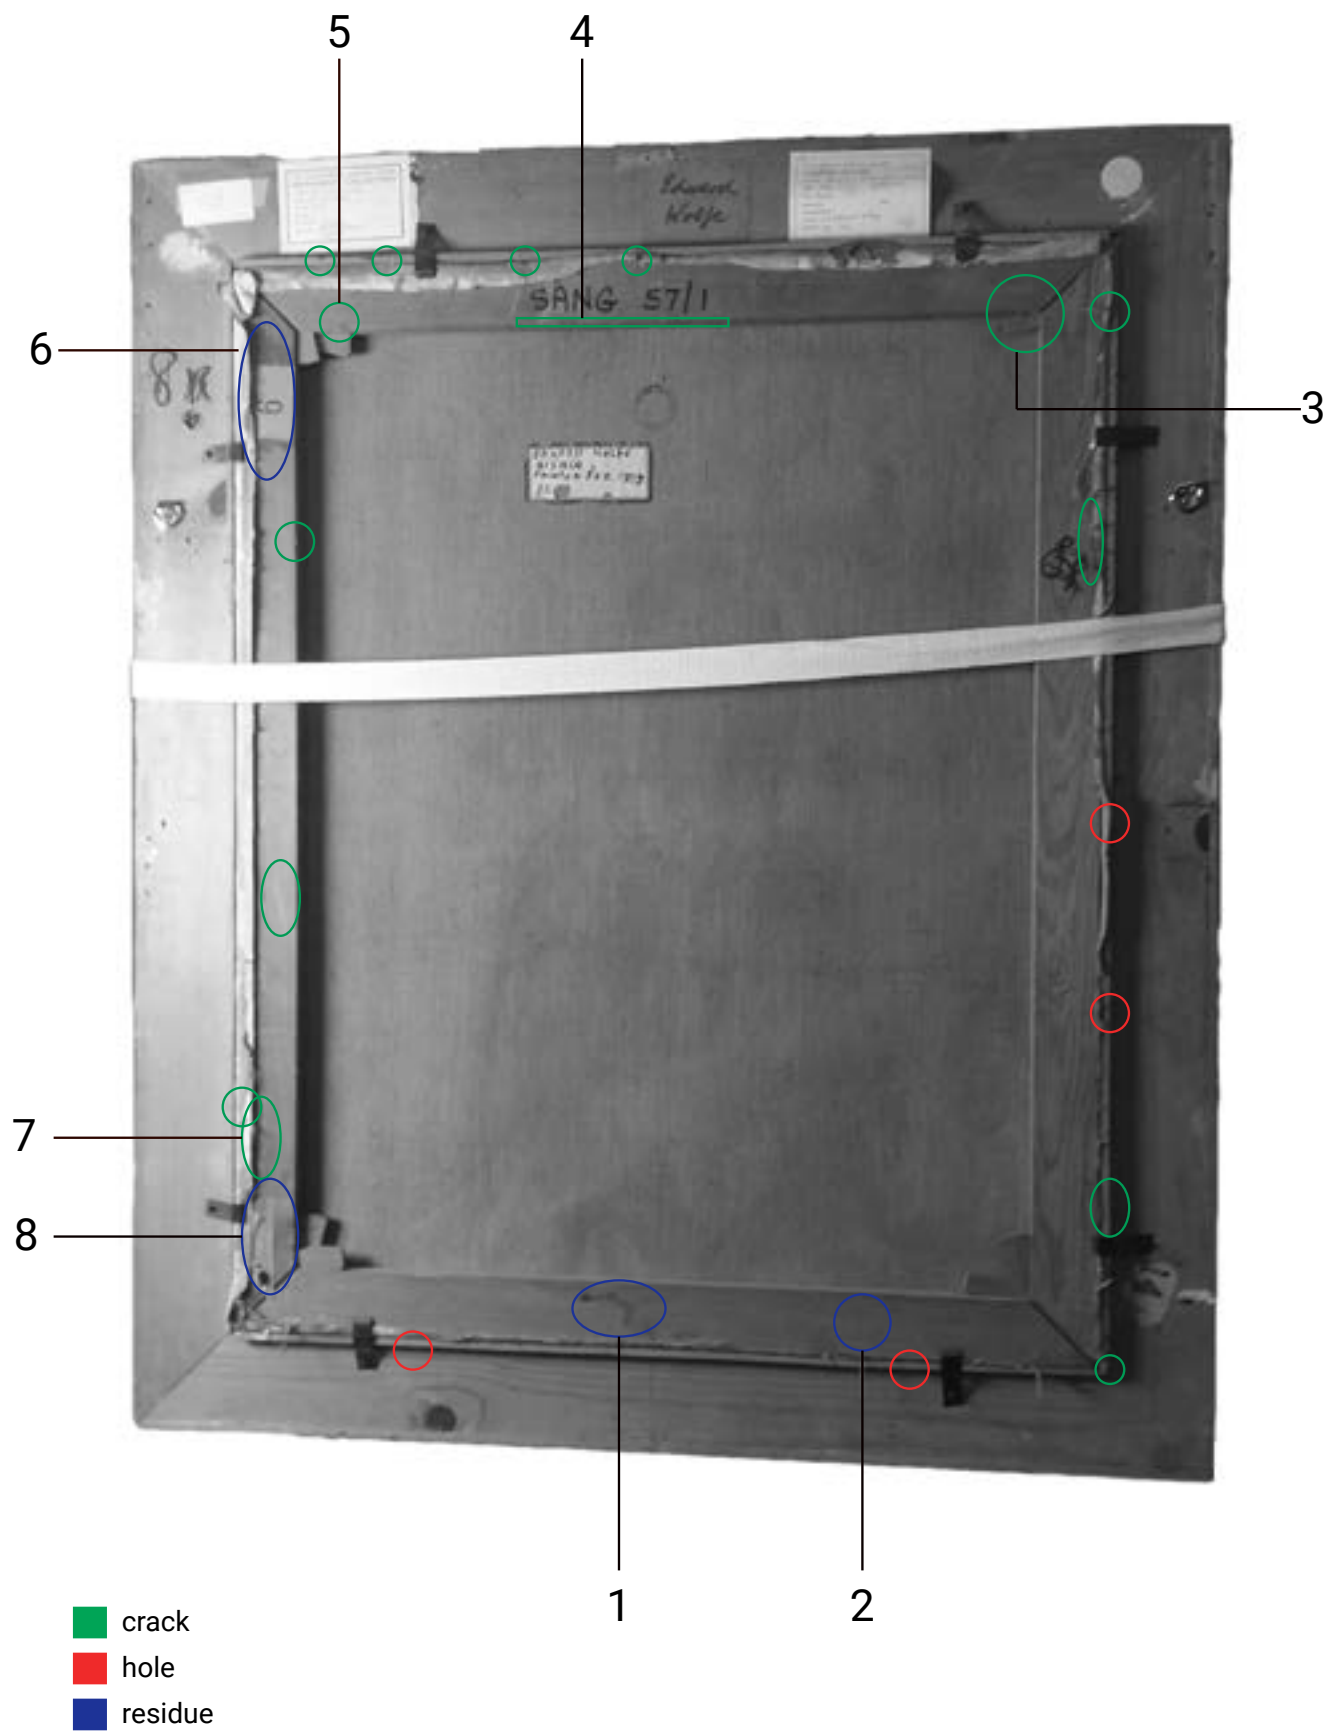
Expansion keys: 7 keys, 1 missing and one damaged in the top right hand corner. They have been taped in (Figure 3)

Overall the stretcher is in good condition regardless of the one missing key and some damage done to the members. The support structure is sturdy and keeps the tension of the canvas taught.

The members at their mitre on the left bottom, left top and right bottom corners there is a gap between the joints. However the explanation keys are still able to hold the joint in place to the support structure stable and taught. Damage can be seen in Figure 3, 4 and 5.

There are dents assumingly due to the secondary support having been mishandled; due to the fact that a soft wood was used or inadequate construction of the support. There are some cracks and chips of wood missing, especially in the inner corners of the support. See figures 3, 4, 5 and 7.

Gum Tape residue and bits of tape is still on. Suggesting it was torn off to remove it from the original. The tape has been cut or torn to remove it from the original support. Seen in Figure 7 and 8. There is also Gum tape stuck on the painted surface of the painting on the right hand top corner and centre with adhesive residue.

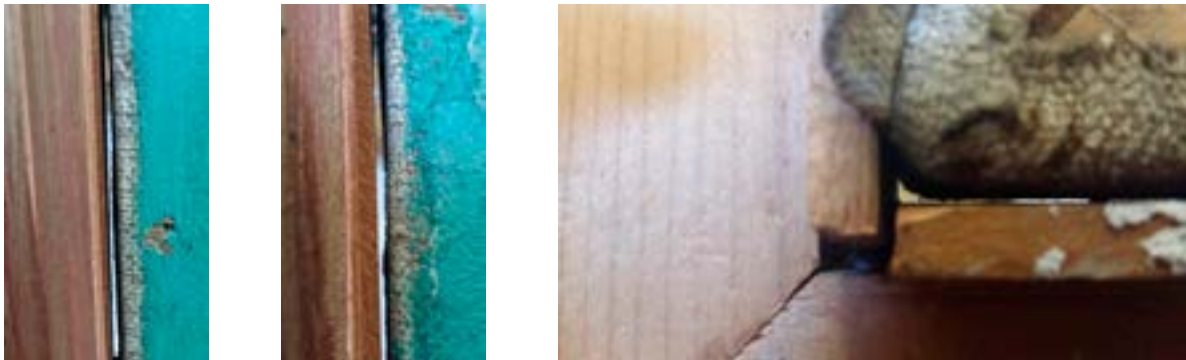
However I am concerned with how the secondary support is connected to the frame. There are visible gaps between the secondary support and the frame as seen in the picture below. A frame may then need to be reattached to the secondary support to ensure the stability of the support.

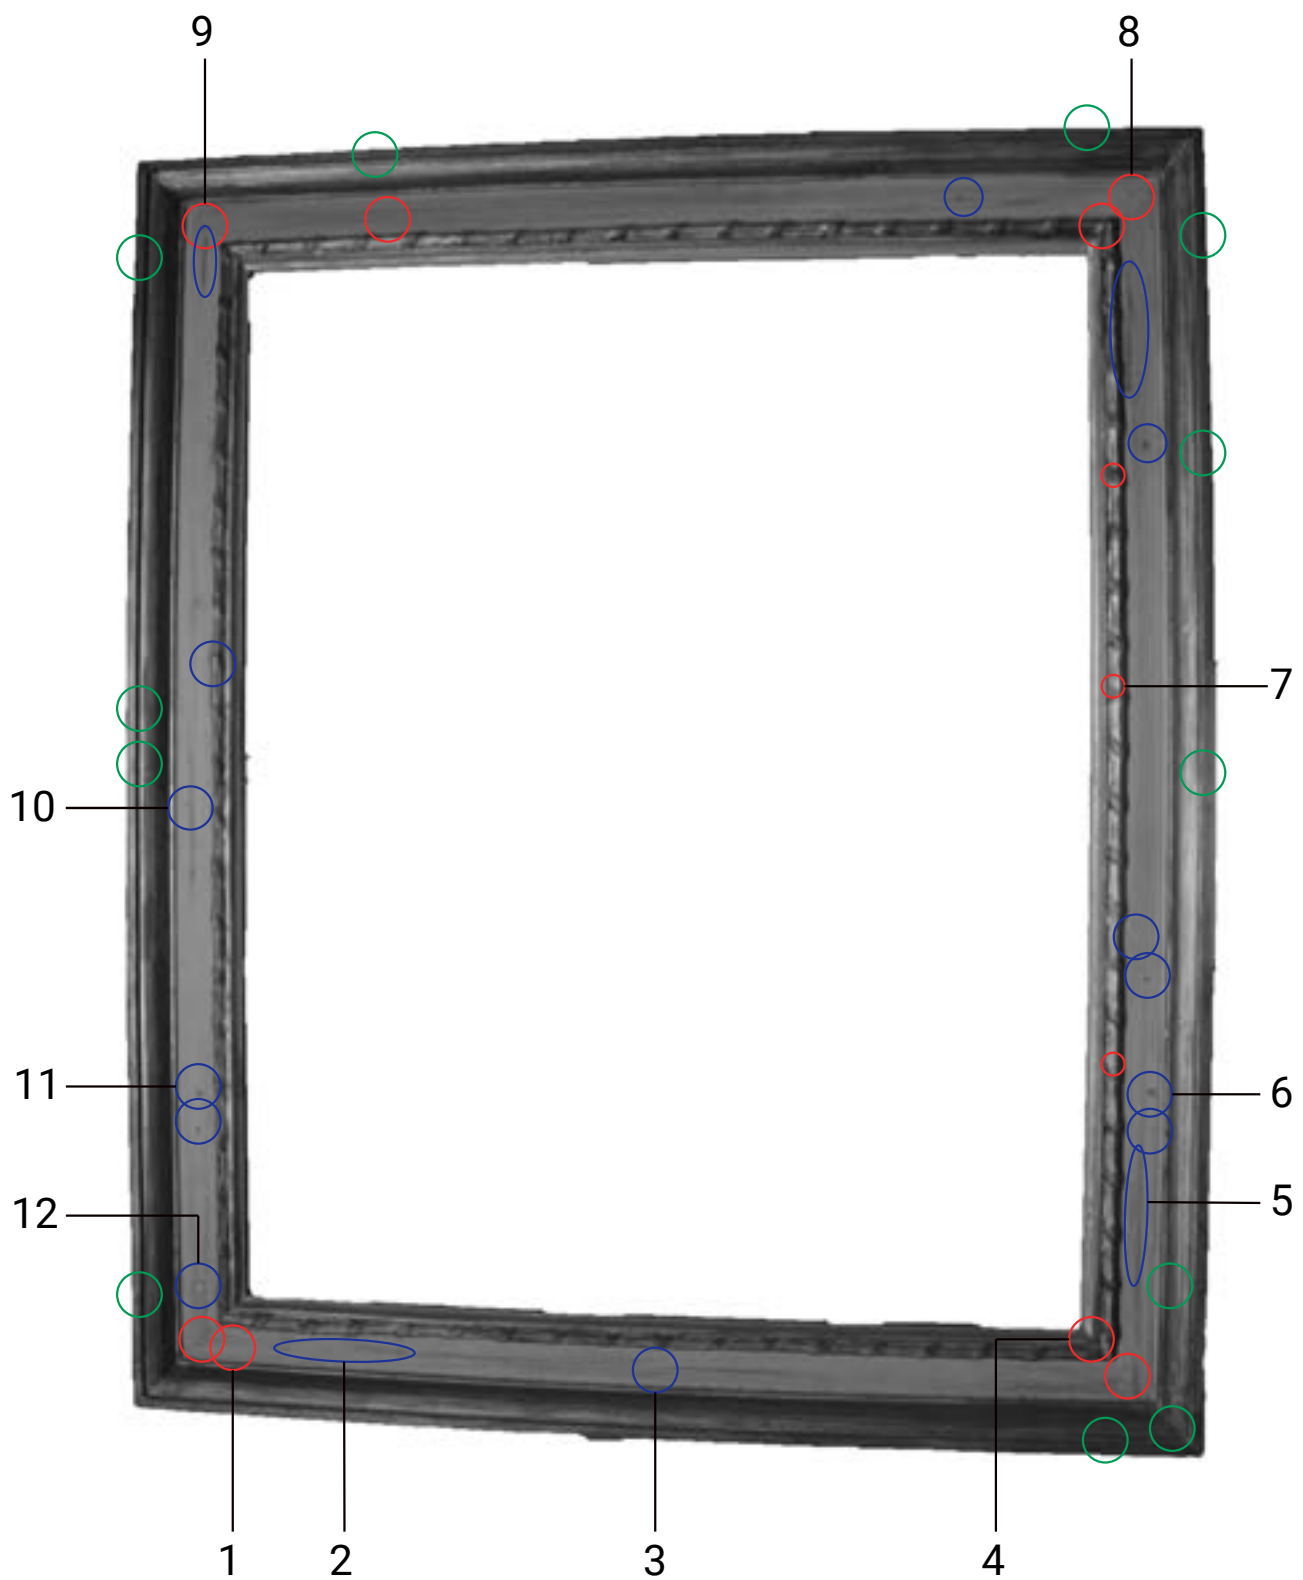
Gesso is a traditional mix of an animal glue binder, chalk, and white pigment, used to coat rigid surfaces such as wooden painting panels as an absorbent primer coat substrate for painting. Its absorbency makes it work with all painting media, including water-based media, different types of tempera, and oil paint. It is also used as a base on three-dimensional surfaces for the application of paint or gold leaf. I assume then that frame was made poorly especially in how the gesso and the frame paint layer was applied. As the paint layer and the gesso dried, the gesso began to bubble through the paint layers forming a hard white plaster like bubble on the surface of the frame. I assume this was caused by careless frame work or that it was done in damp/ humid conditions. Along the inner edges of the frame and in the middle section there are dark spots varied in size and shape of mould growing on the frame. Refer to Frame Front figure 1, 5-6 and 10.

There are partials of dirt and dust that have built up on the frame, making the frame appear dull and lowering the condition of the frame. Among the dirt build-up there are also areas with mildew on the inner edges of the frame. Refer to Frame front figure 3, 6, 8 and 11.

The structure of the frame is relatively sound. However there are cracks in the inner corners of the frame. Refer to Frame front figure 4 and 9. In the middle left member there is a hole, refer to figure 10.

The frame was apparently not well cared for when it was constructed and as a result the frame's condition would have deteriorated, additionally it is apparent that it has not been well maintained. It would need to be restored for it to be structurally sound for the painting. The frame adds authenticity to the painting, with all the marks, labels and inscriptions which makes it an important part of the painting. I suggest then that the frame should be restored.

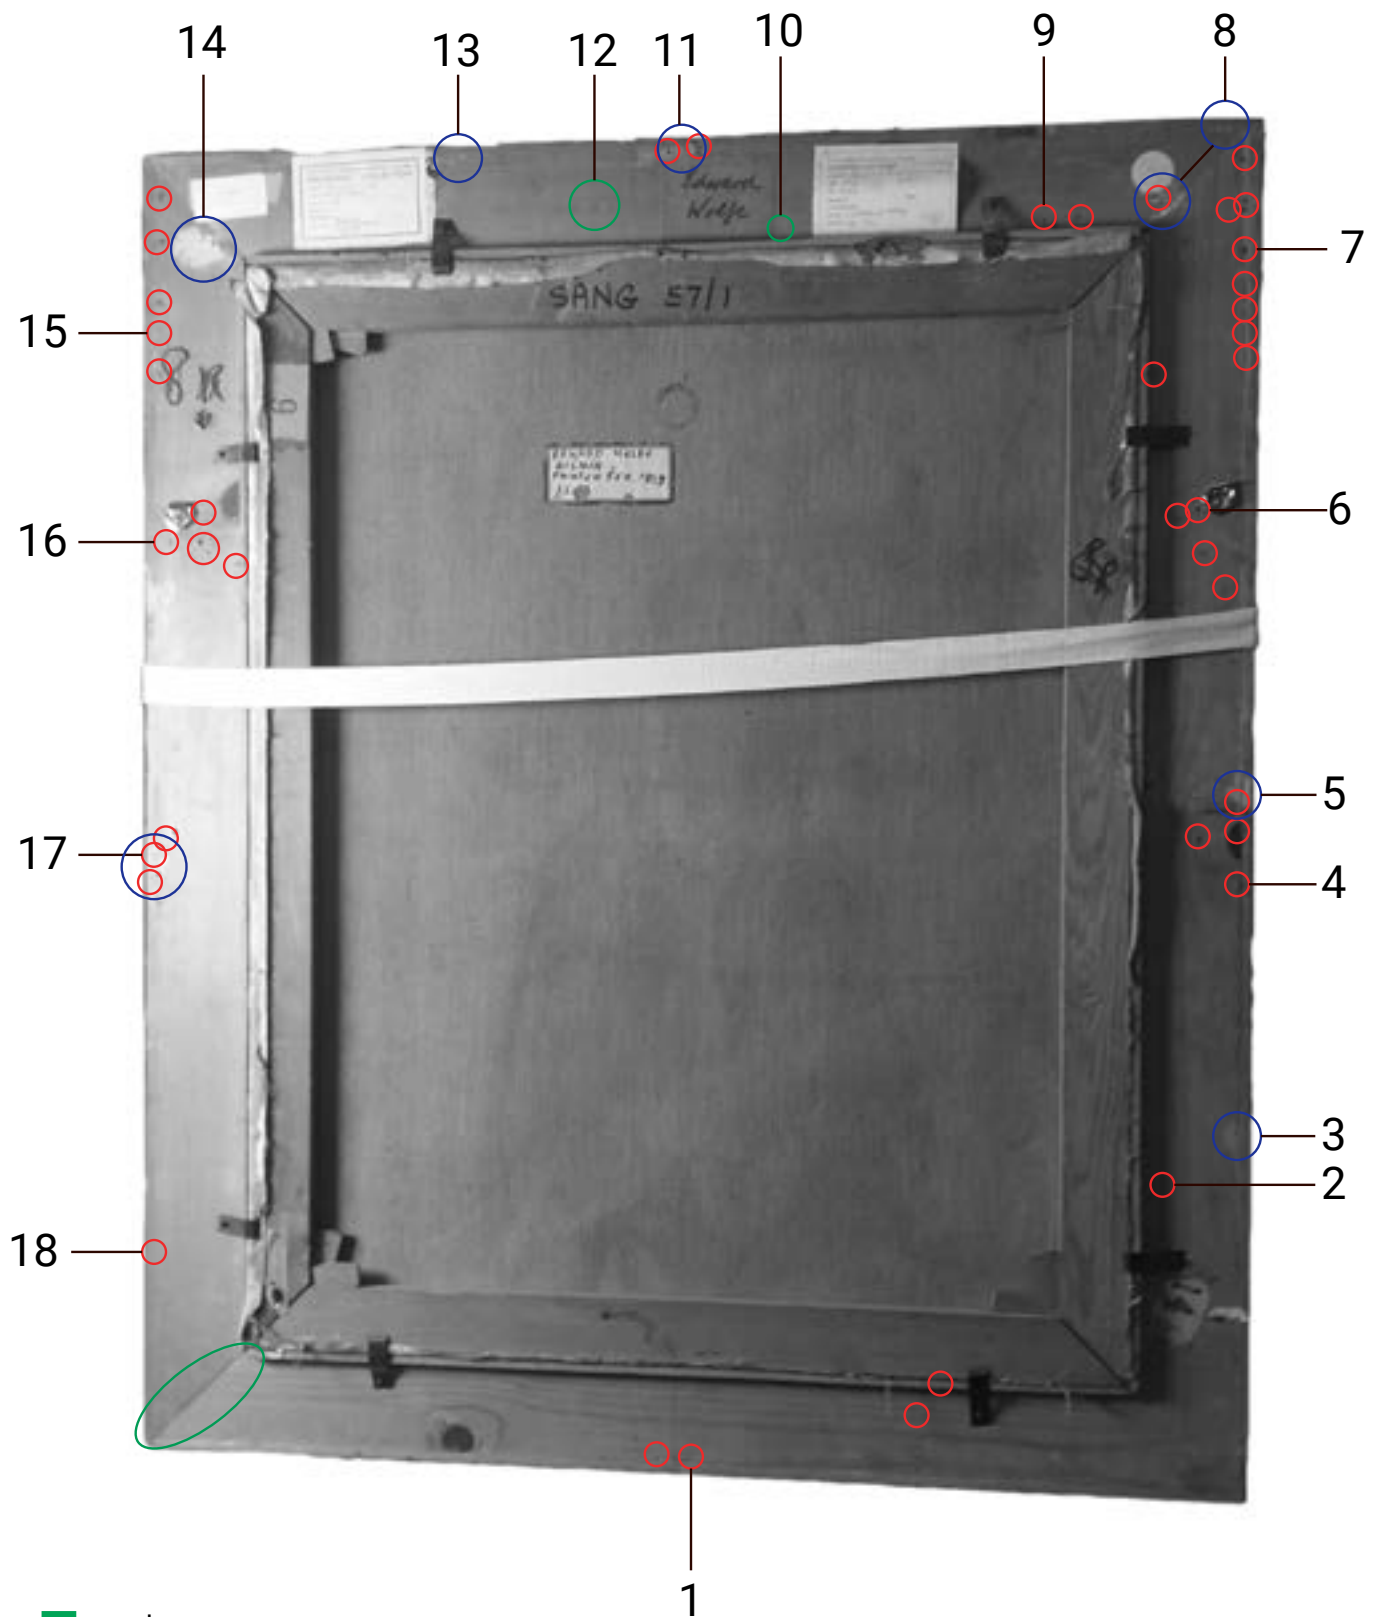
As stated earlier the front of the frame is in poor condition. It is also seen in the back of the frame. Along the outer edges of the frame there are drilled holes, and around the frame's D- hook's and around the centre of each member. It shows the lack of care the frame has endured.

There are a few areas with dents, however not any that would compromise the structure, refer to frame back figure 10 and 12. There is a slight crack that runs through the left hand corner. It may need to be repaired so as to not continue the neglect of its poor condition.

There are areas of the frame that have wood filler residue, showing signs of repair. Refer to frame-back figure 5, 8, 14 and 17.

There are paint and red bole splats on the back of the frame when the front of the frame was being prepared, showing careless construction of the frame. Refer to frame-back figure 8 and 9.

Glue residue is also seen in areas where labels have been stuck down and where frame joints have been stuck together, refer to frame-back figure 8, 11 and 13.
