Condition Report: *Music-Making Couple*

Completed by Lisa Truter on 15/05/2016

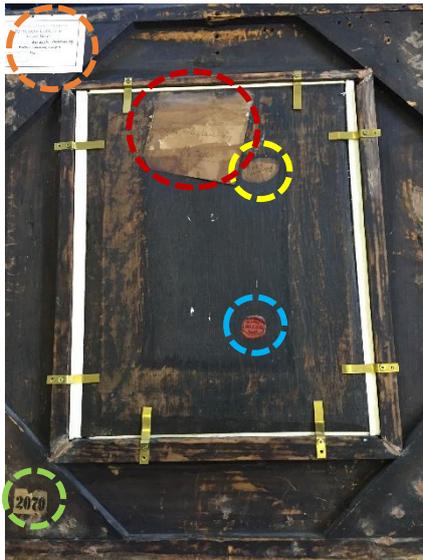
The reverse of the panel has had several different ‘labels’ adhered to it. Figure 2 adjacent depicts the layout of these pieces, 5 individual markings which have been circled for easy identification.

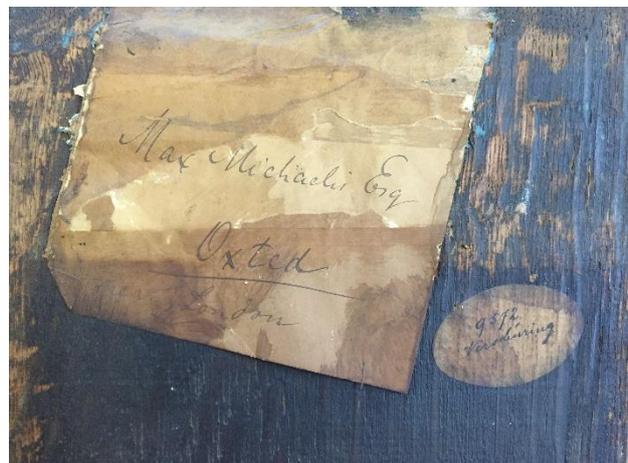
The largest of these pieces, found at the centre of the top edge of the panel, and circled in **red**, has written on it the title “Max Michaelis Esq”. Below this one can read; “Oxted” and “near London”. A close up image of this can be seen at Figure 3 below. This marking may have been attached to the work upon its acquisition by Hugh Lane on behalf of Sir Max Michaelis.

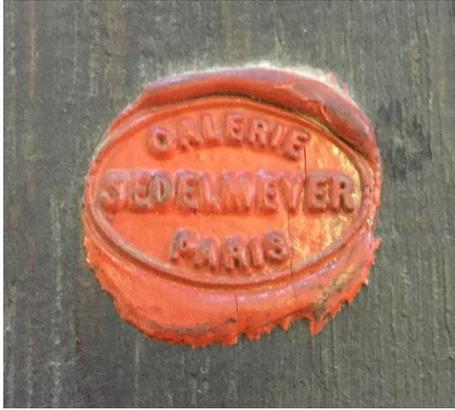
Below these aged pieces of paper, toward the bottom edge of the panel (circled in **blue** at Figure 2), is a red wax seal. As can be seen in Figure 4 below, the seal reads; “Galerie

Sedelmeyer, Paris”. The gallery, owned by Austrian art dealer and collector, Charles Sedelmeyer (1837-1925), is known as having exhibited and sold works of the Old Dutch Masters, including the likes of Rubens and Rembrandt. It is not known if this piece was purchased from this gallery for Sir Max Michaelis, or if a previous owner had purchased the work from here.

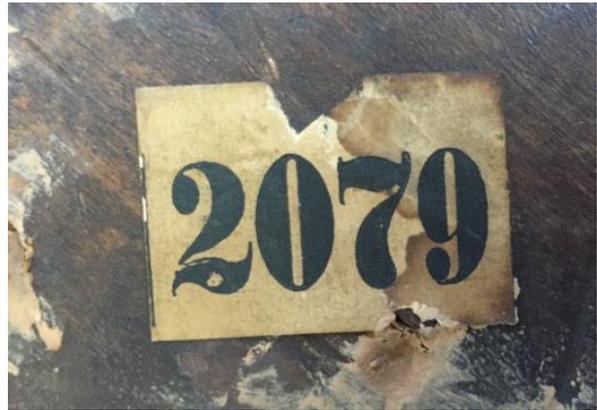
Figure 5

The remaining to pieces on the reverse of the painting are actually placed on the reverse of the frame. Circled in **green** at the bottom left-hand corner of figure 2 and pictured in detail at figure 5 is the number “2079”, the paper upon which this is printed appears to have aged similarly to the pieces discussed in figure 3 and thus could be presumed to represent another accession number or lot number.

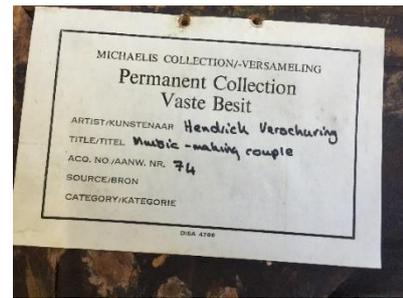
Figure 6

In contrast to this, the piece at the top left-hand corner of the frame and circled in **orange**, is a more recent addition; a label added indicating the painting’s inclusion in the Michaelis collection. The artist’s name, the title and the accession number can be seen listed here, as indicated in figure 6.

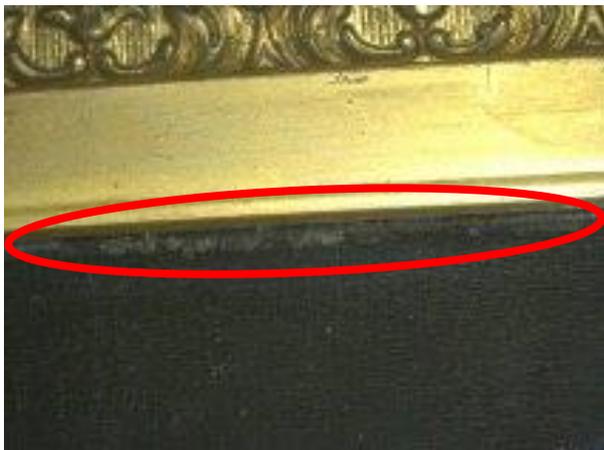
Figure 7

being a more recent addition is found also in the fact that flaking and scuff marks are evident in places along the edge of the panel, most notably along the top edge, as pictured in figure 7.

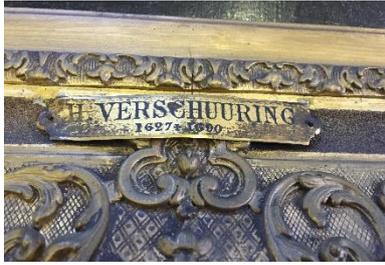
Figure 8

As can be seen in the adjacent image, a title plate has been tacked to the bottom edge of the plate, listing the artist's name, along with his birth and death dates.

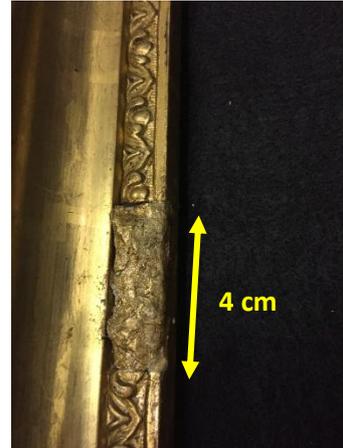
In its entirety, the frame appears to be in good condition with little damage to its exterior as well as being structurally sound and rigid. Notable damage is seen on the outer most edge of the frame, on the top right hand edge. Previous restoration has been attempted on this 4cm long piece, with what appears to be putty or clay that has been painted gold, this can be seen in Figure 9 alongside.

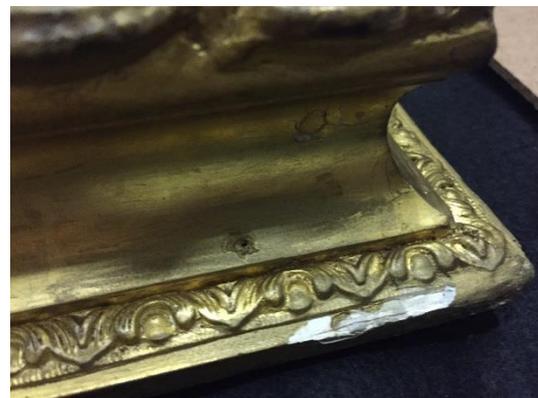
Figure 10

Other notable damage has occurred along the bottom, outermost edge of the frame, the frame has been chipped in several places, consequently exposing the white colour of the underlying material.

These chips vary, and although not as deep as the aforementioned damage to the right-hand side of the frame, reach lengths of up to 2cm in certain places (seen in figure 10). Fine cracks at the centre of the top edge of the frame, as well as an arch shaped crack at the innermost edge of the right hand side of the frame are also visible.

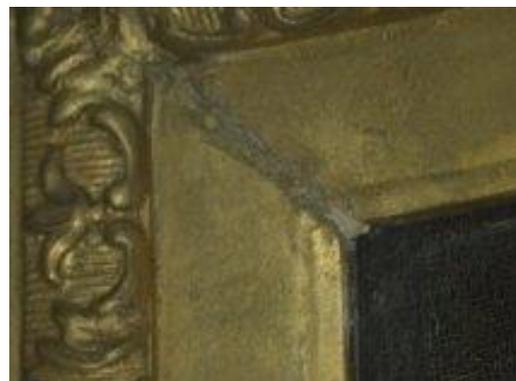
Figure 11

Splits can be seen at all four mitres, these too also appear to have been previously repaired using a similar, or the same material as referred to above with regard to figure 9. This repair work is evident in figure 11.

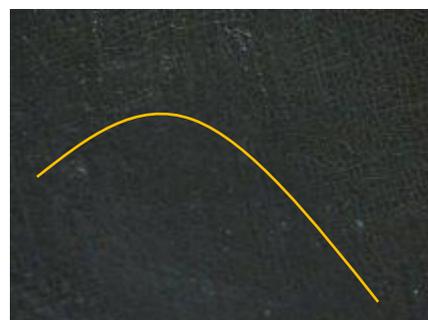
Figure 12

The oil paint appears to have been applied finely and evenly. No signs of drying cracks or of flaking are apparent, although the surface in its entirety is covered in a network of age cracks. This craquelure appears to be unevenly distributed, however. As can be made out in the adjacent micrograph image in figure 12, age cracks are substantially more evident in the dark colours of the background, in contrast to the two figures in the foreground. The yellow curve indicates where the craquelure pattern changes from less apparent within the curve, to more noticeable outside of the curve. Potential reasoning for this will be explored in the report on varnish layer later. The overall pattern of the craquelure can be seen in the micrograph image at figure 13.

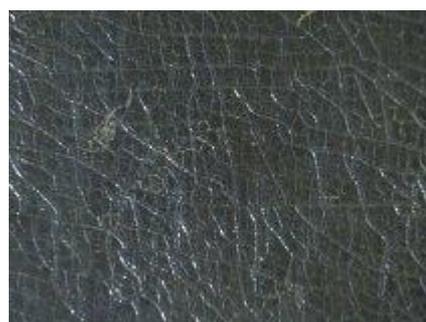
Figure 13

Although, upon initial inspection the surface of the painting appears to be clean, only with small amounts of dust present, study under Ultra-Violet light, however revealed to surface to be largely unclean. Furthermore, study under micrograph rendered apparent the milkyness of the surface, possibly and most likely due to surface bloom. This bloom probably occurred as a result of exposure to poor climate conditions, particularly humidity. This is not surprising given

the lack of climate control in the Old Town House where the piece is most prominently housed. The fact that the frame was previously accompanied by a glass glaze, may also have contributed to this damage.

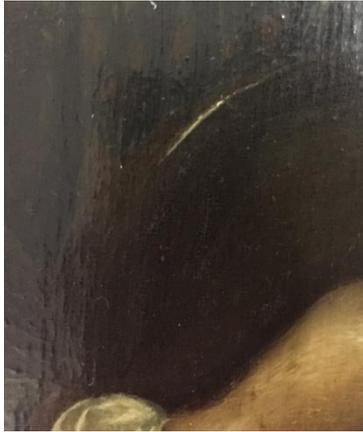
Figure 14

Abrasions to the paint layer are visible yet not major. The most notable abrasion can be seen along the top curve of the lyre (Figure 14). A less apparent abrasion is seen on the top left hand corner of the painting and runs vertically down the image, it is approximately 2cms long.

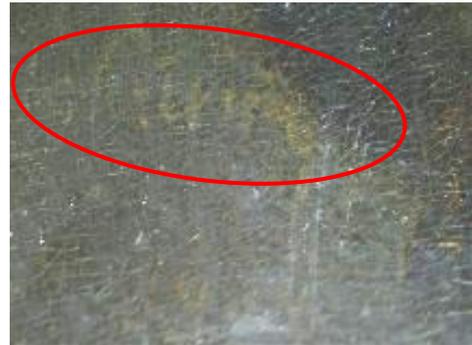
Figure 15

It can be speculated that additional layers of varnish have been more recently applied, given that the artist's inscription is today so obscured. A micrograph image of this extremely faint signature, on the left hand-corner of the painting, can be seen at Figure 14. Although it is evident that some sort of inscription exists, it cannot be confirmed exactly as to what this inscription reads.
