CONDITION REPORT

Lady Beatrice Glenavy (née Elvery)
The Picnic (The Expulsion from Eden)

Conducted by Marc Orion Smith (UCT Student No. SMTMAR055) at Iziko South African National Gallery, April 2016.

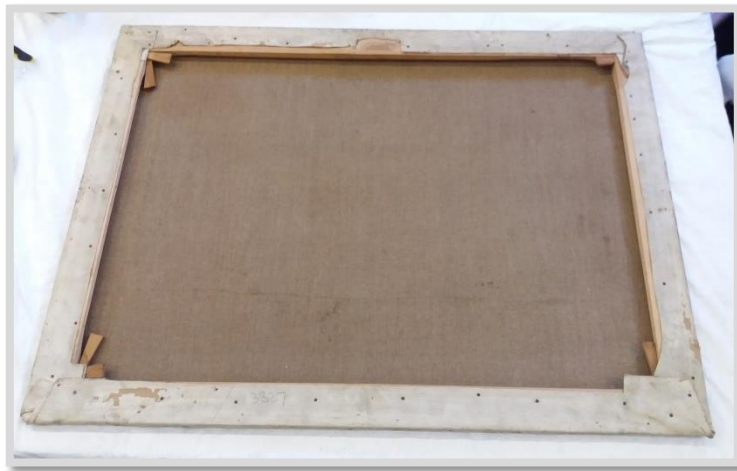
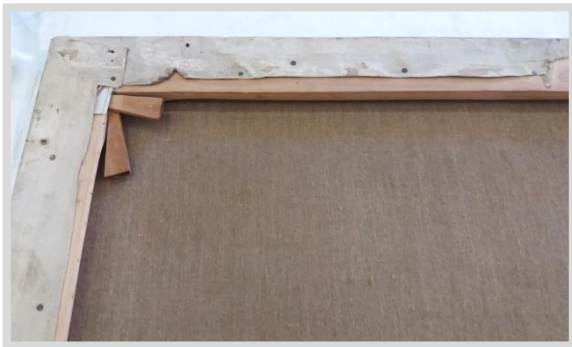
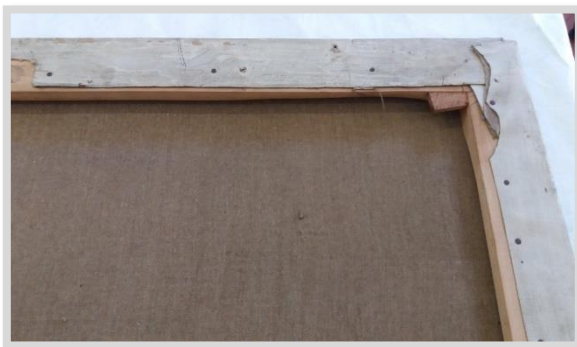
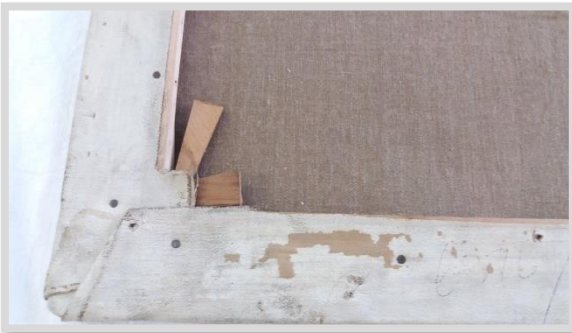
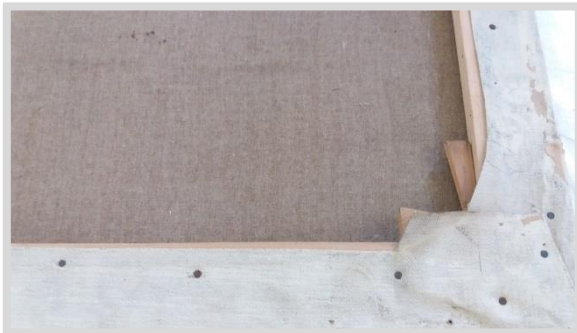
Primarily, the secondary support appears rather stable and secure, with no apparent signs of having detrimental effects on the primary support or paint layers. The canvas has been stretched over a wooden stretcher consisting of four members. A precise measurement of each member could not be taken due to the covering of each individual member by the canvas. However, the overall dimensions of the members (arranged in a rectangular formation) is as follows: 570 x 765 mm. The thickness of each member measures 17 mm. The members are joined by means of Mortise and Tenon joints. There are seven keys in total with one key top-right presumably missing. The keys are neither tied nor taped.

Images taken of the back of the unframed artwork to document the appearance of the secondary support immediately visible upon initial inspection. Close-up images have been taken of the corners where the individual members of the secondary support meet and the keys are inserted.

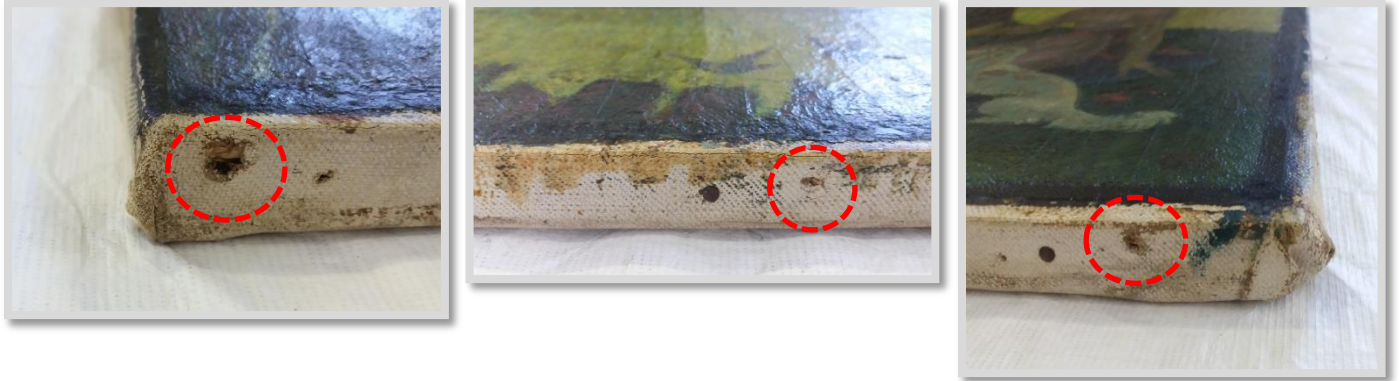
The presence of empty tack holes along the tacking margin suggests that the secondary support is not the original. There are no visible inscriptions or labels on the secondary support.

Images taken of the empty tack holes (circled in red) visible along the bottom of the artwork suggesting that the secondary support might not be the original.

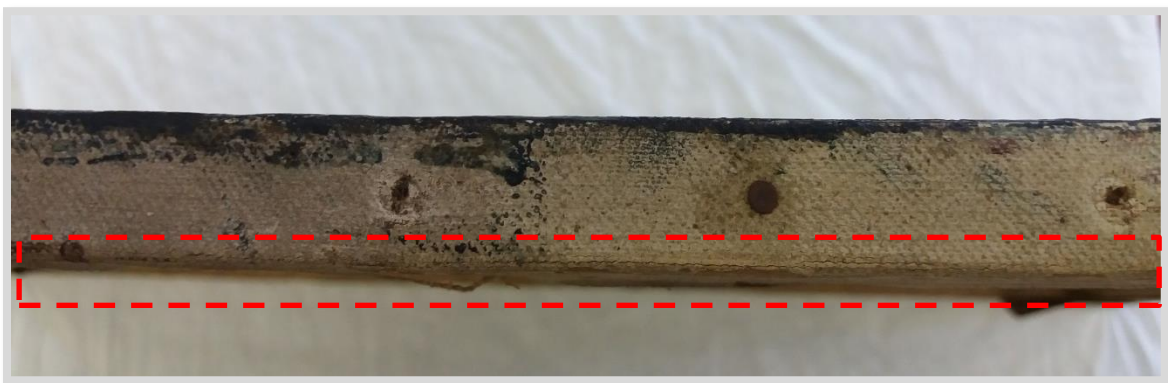
Image taken of the top edge of the artwork exhibiting cracks (outlined in red) in the primary support where the canvas wraps around the edges of the secondary support.

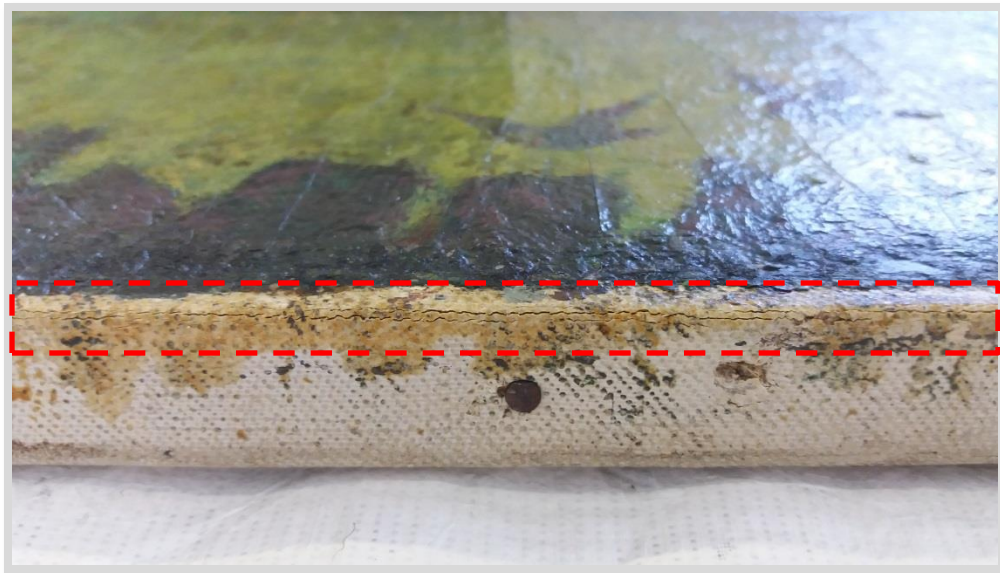
Image taken of the bottom edge of the artwork exhibiting cracks (outlined in red) in the primary support where the canvas wraps around the edges of the secondary support.

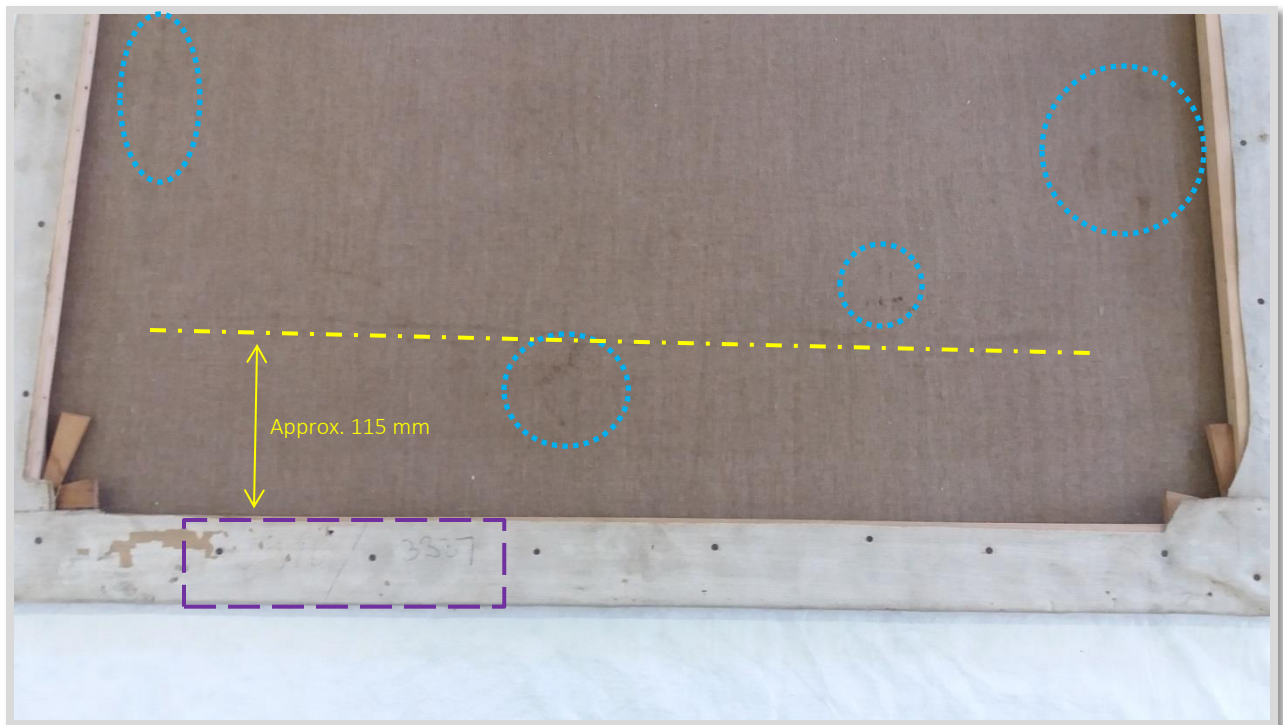
Image taken of the reverse, lower-half section of the artwork exhibiting minor stains (circled in blue), a horizontal marking line (underlined in yellow), and the inscribed number sequence 6376 / 3337 bottom left (outlined in purple).

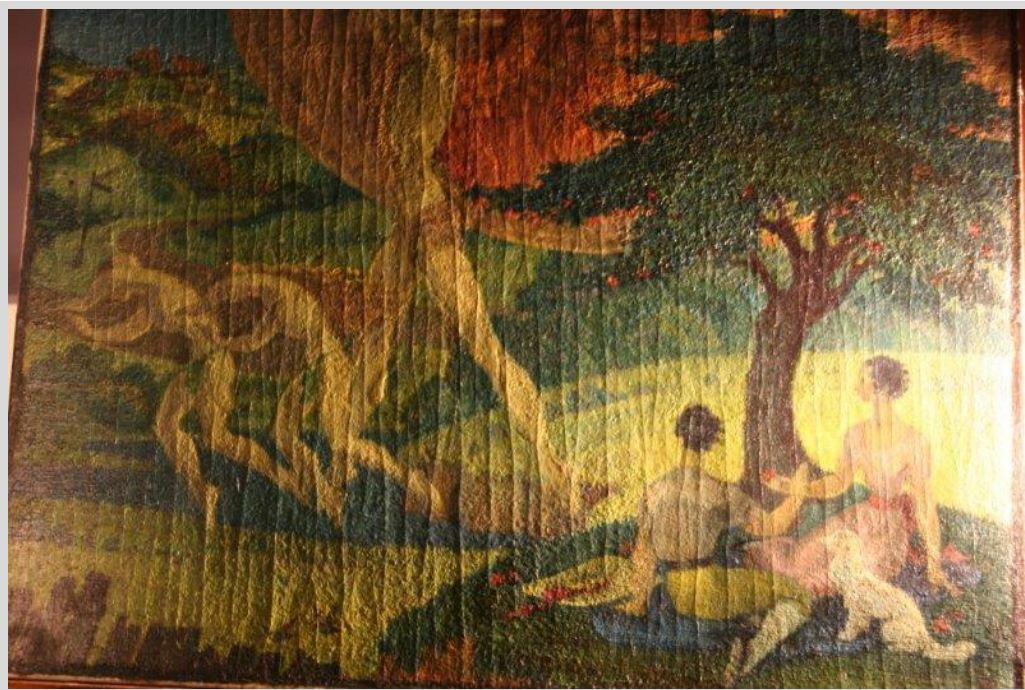
Immediately apparent in relation to the artwork's overall appearance and paint layers is the excessive presence of various cracks (primarily vertical) that stretch across nearly the entire surface plane, where paint has been applied, in a fairly uniform and parallel arrangement. The presence of these cracks are likely the result of the painting canvas having been incorrectly rolled (i.e. rolled with the painted layer facing inwards and not outwards) at a particular point of time for the purpose of transportation, storage, or the like. These cracks, which appear to align with the canvas weave, also suggest that the canvas has been removed from its secondary support at some stage after the painting was originally completed.

For the purposes of this condition report the painting's frame was removed, after which a site count was conducted with the use of a magnifying glass in order to ascertain the number of cracks visible under minor magnification. After counting, it was observed that an excess of 78 noticeable cracks are present along the top edge of the painting and run down vertically towards the inner segments of the picture plane. Similarly, an excess of 45 noticeable cracks were identified as being present along the bottom edge of the painting and run upwards in a vertical direction towards the inner segments of the picture plane. The darker sections of paint, representing the shade cast by the tree on the right of the painting, exhibit cracks with larger intervals or sections in between them when compared to the lighter areas of paint towards the left of the painting. Collectively, the painting's cracks are most visible under raking light.

Raking light photograph exhibiting the surface typography of the artwork and detailing and highlighting the crack formations found across the artwork's surface plane where paint has been applied. These cracks are likely the result of the painting canvas having been incorrectly rolled after being removed from the secondary support. The use of raking light also emphasises the textured quality of the paint layers.

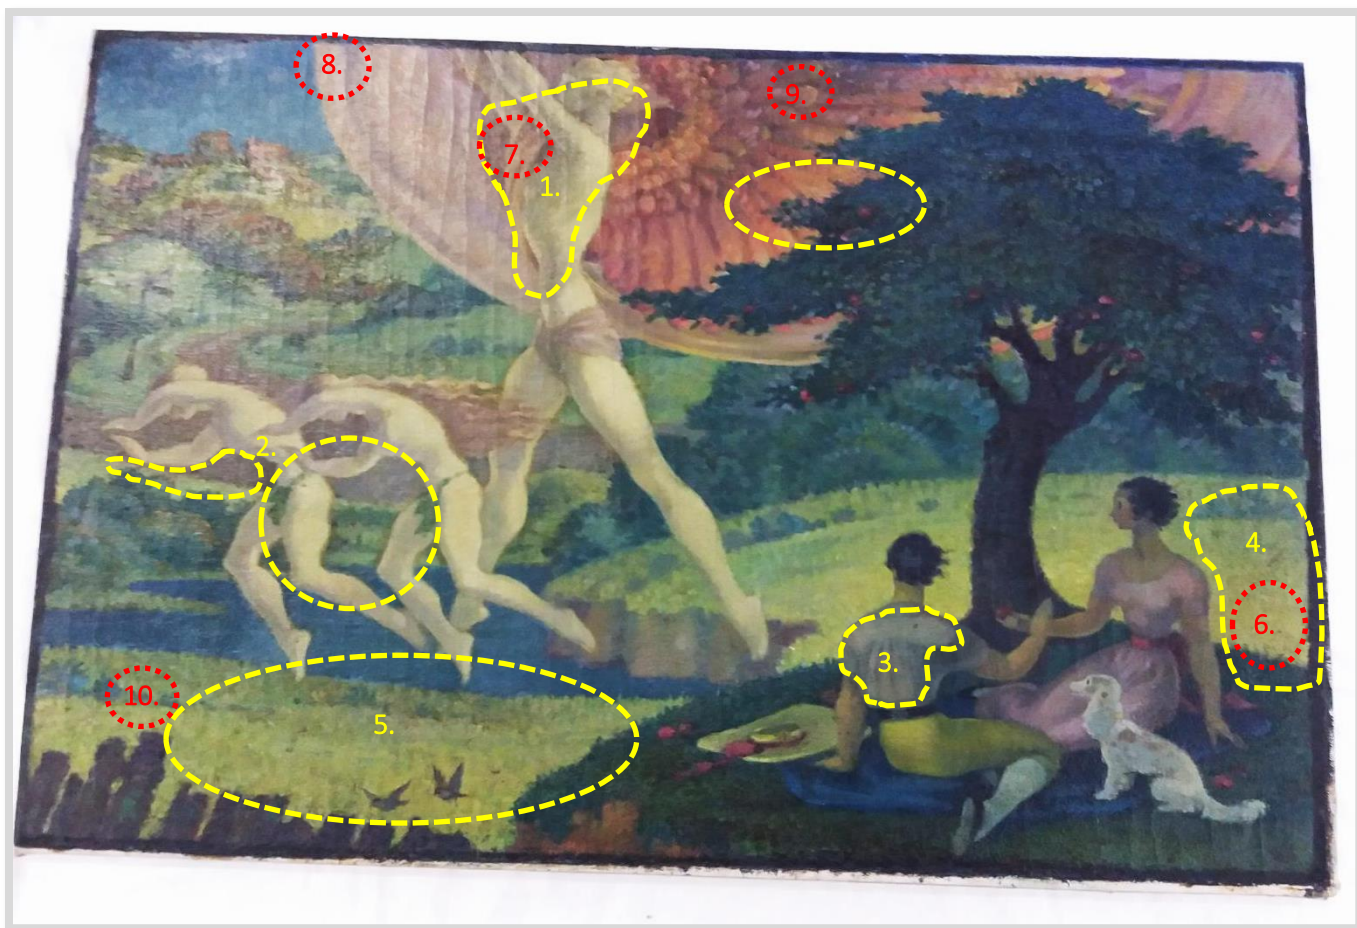
Furthermore, the presence of typical age and drying cracks are visible within the paint layer. The artwork has a significantly darkened appearance throughout, which is likely the result of the artist having applied a dark imprimatura layer/glaze to the painting's ground. There are a number of areas where the imprimatura layer has worked through the paint layers applied atop of it and has become visible through the drying cracks present, thereby creating the appearance of grime and surface dirt deposits in numerous areas. The imprimatura layer is visible as a dark, seemingly sticky black residue or stain spot resembling that of brown-black varnish. Areas where such appearances are most visible have been photographically documented. Moreover, due to the presence of painting's dark imprimatura layer it has presently been difficult to ascertain whether the painting has been restored by means of retouching or overpaint, despite examination of the painting underneath ultraviolet (UV) illumination involving the Blacklight Blue (BLB/UVA) method. To this effect, a more specialised, detailed and closer examination of the painting is recommended. In addition, a number of paint losses resulting from abrasions to the upper most layers of paint have also been photographically documented.

Image mapping the paint layer characteristics and their associated locations: the permeation of the dark imprimatura layer (outlined in yellow) and paint losses/abrasions (outlined in red).

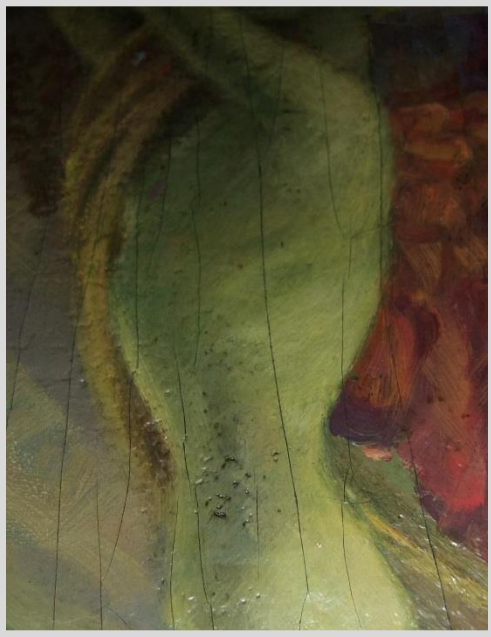
1. Close-up image revealing the permeation of the dark imprimatura layer along the torso of the angel (central figure). The imprimatura layer is visible as a dark, seemingly sticky black residue/stain spot resembling that of brown-black varnish.

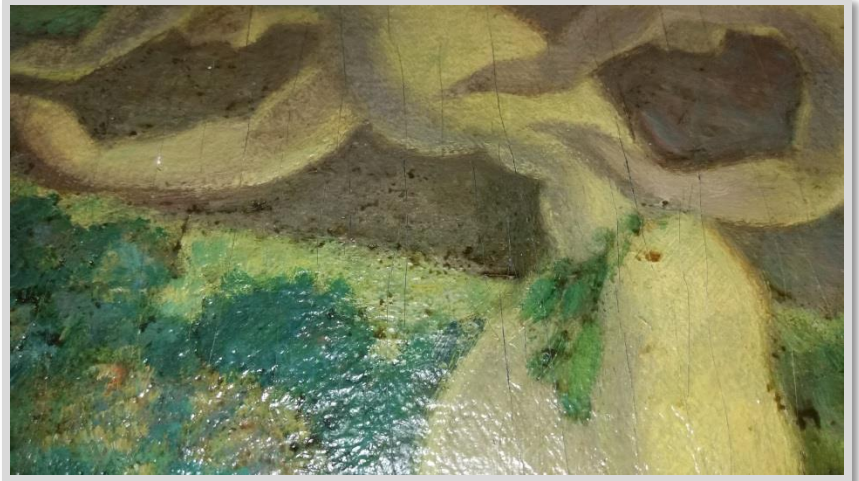
2. Close-up image revealing the permeation of the dark imprimatura layer underneath the arms of Adam and Eve (two figures on left-hand side of painting).

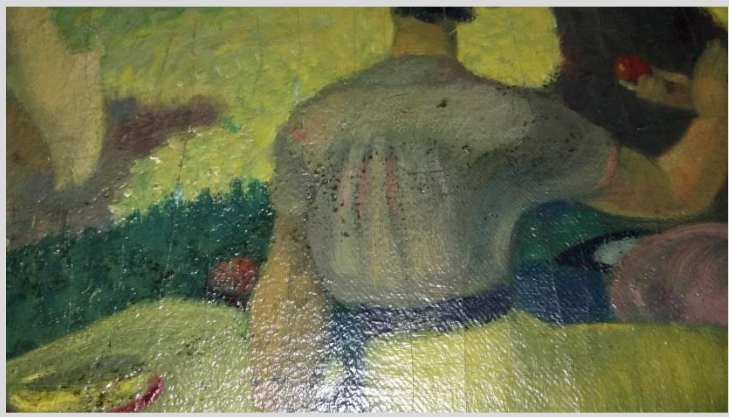
3. Close-up image revealing the permeation of the dark imprimatura layer on the back of the left-hand seated figure underneath the tree.

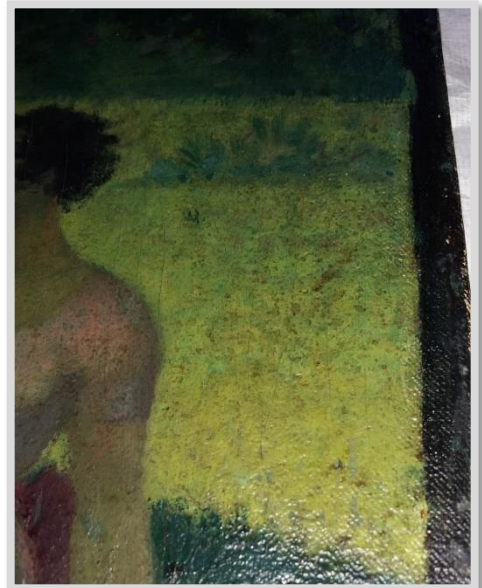
4. Close-up image revealing the permeation of the dark imprimatura layer on the far-right grass embankment.

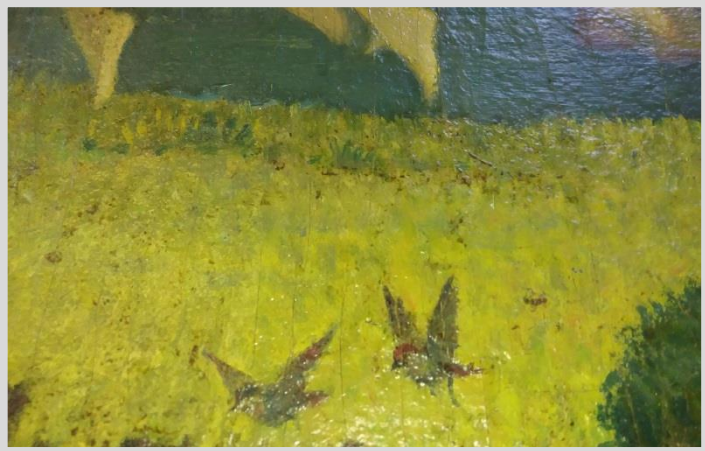
5. Close-up image revealing the permeation of the dark imprimatura layer along the grass segment beneath the feet of Adam and Eve.

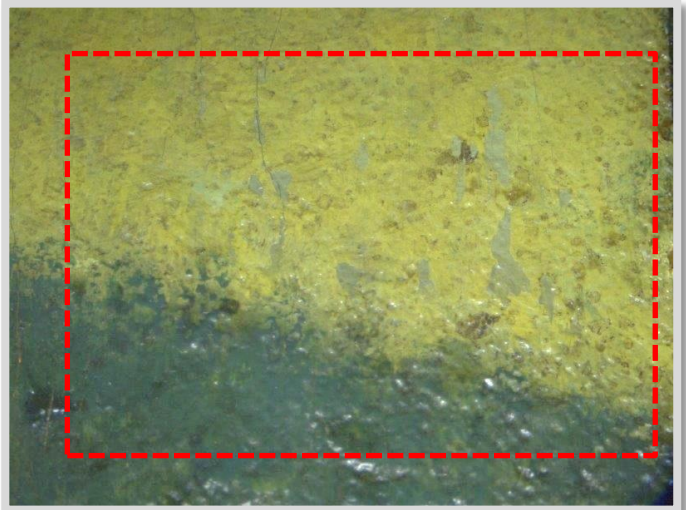
6. Micrograph image (x6.4 magnification) detailing paint losses (outlined in red) of the upper paint layer on the far-right grass segment located slightly above the shaded, darker-green section of grass.

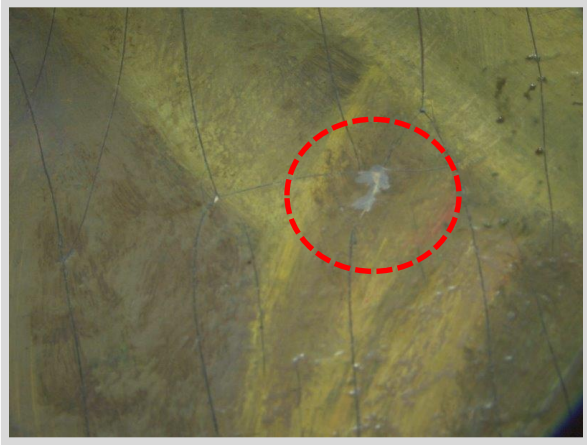
7. Micrograph image (x6.4 magnification) detailing a site of paint loss (circled in red) on the upper torso of the angel figure.

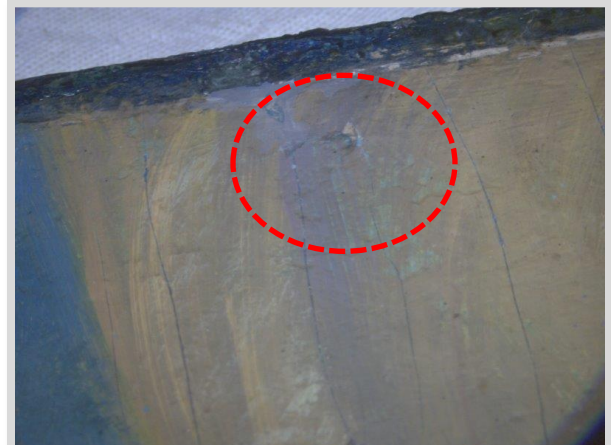
8. Micrograph image (x6.4 magnification) detailing a site of paint loss and abrasion (circled in red) on the upper left-hand segment of the angel's cape.

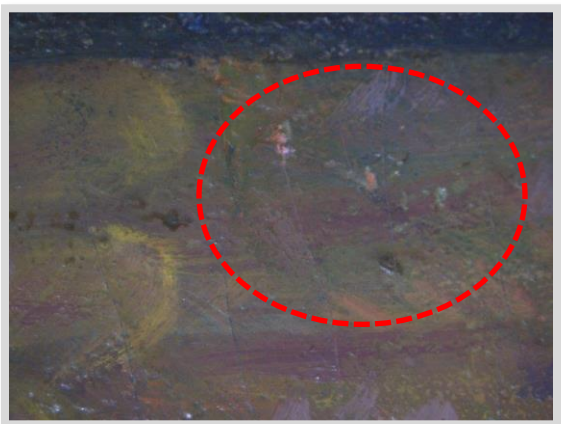
9. Micrograph image (x6.4 magnification) detailing a site of paint loss and abrasion (circled in red) on the upper, central segment of the angel's wing.

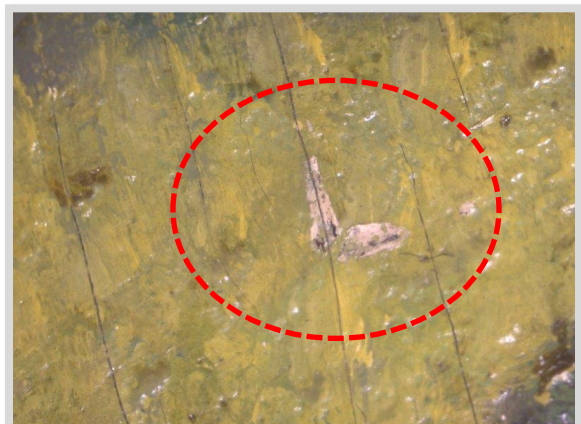
10. Micrograph image (x6.4 magnification) detailing a site of paint loss (circled in red) on the lower, left side segment of the grass embankment.

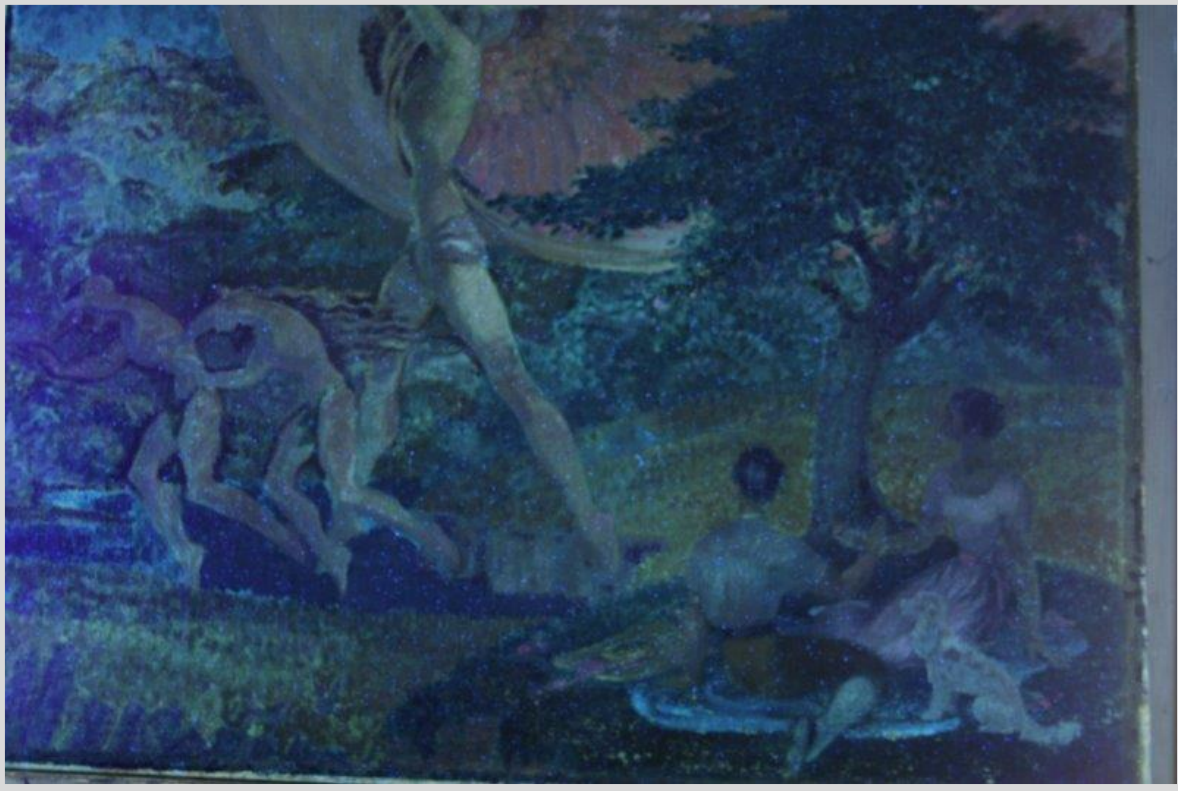
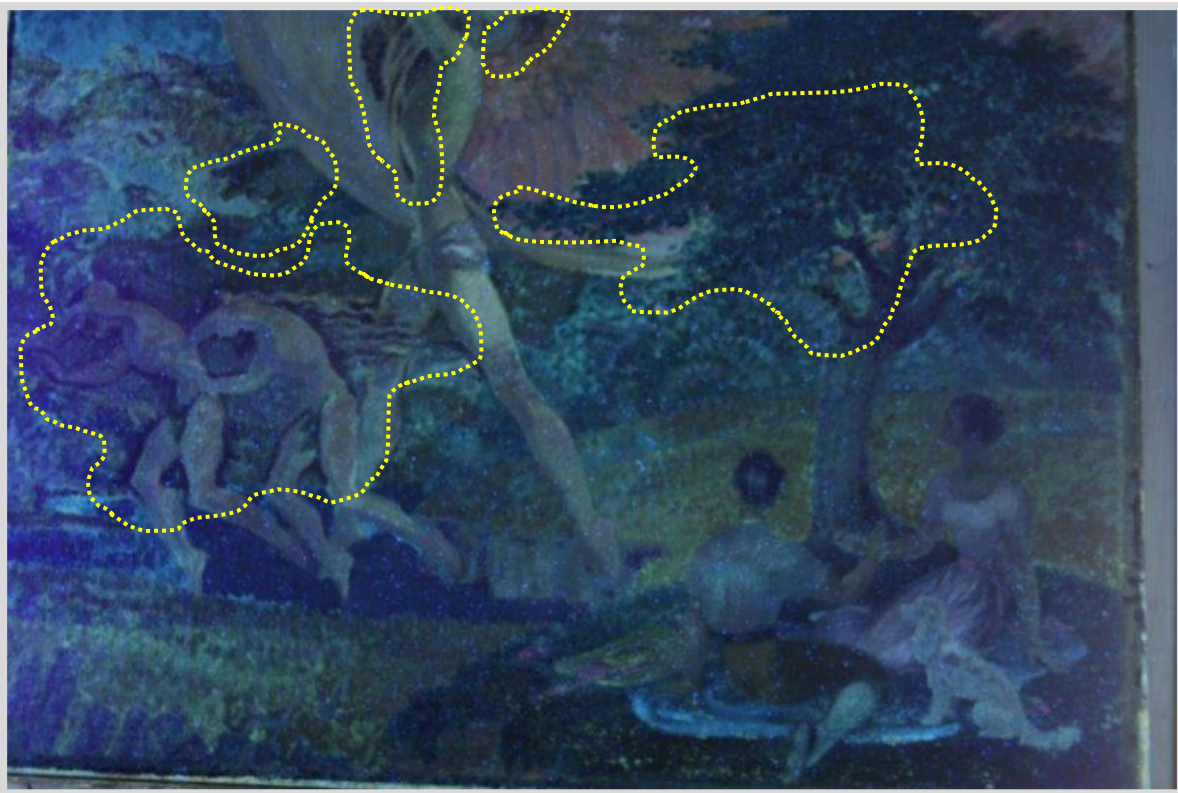
Image(s) taken under UV illumination

Image taken under UV illumination. It is presently unclear whether or not the darker sections (outlined in yellow in the image below) are due to retouching or overpaint, or whether these sections appear darker on account of the permeation of the dark imprimatura layer located below the paint layers.

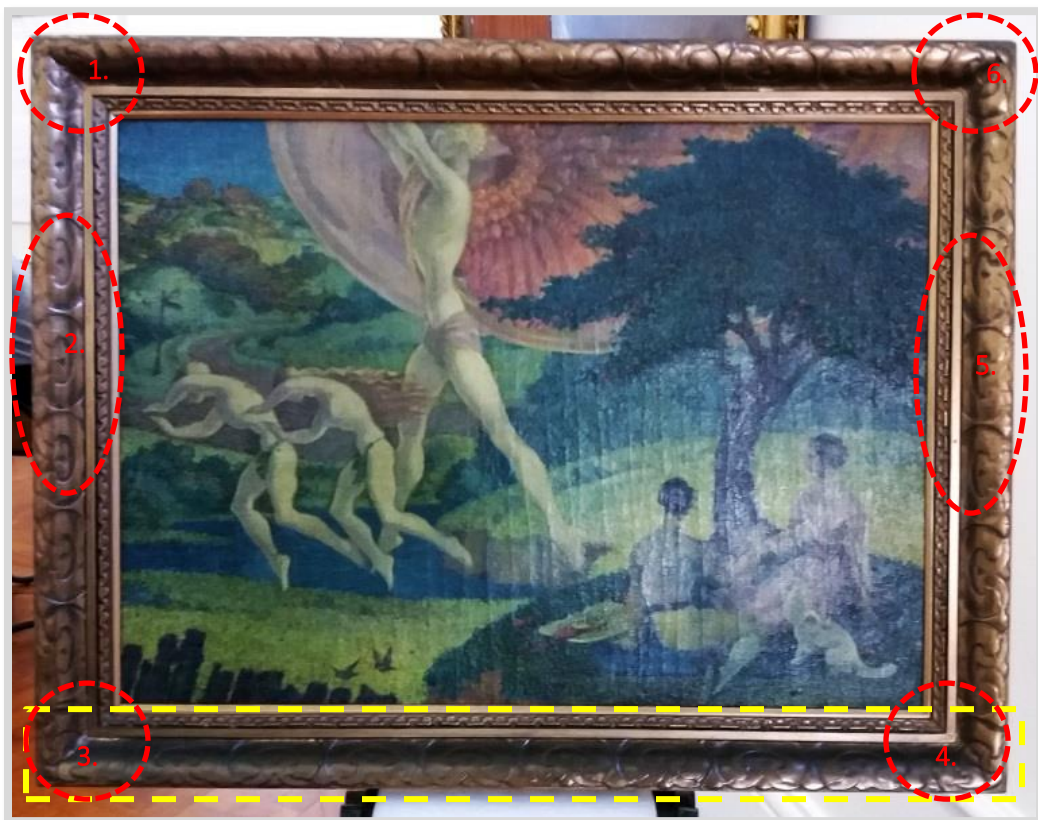
The broadest segment of the frame has a darkened appearance along the bottom edge. This discolouration is likely due to dust and other domestic pollutants that have repeatedly settled along the frame's lower edge and which have repeatedly been wiped clean during household cleaning or dusting of the frame over the span of several years. Structurally, the frame appears stable and secure with no signs of having a detrimental effect on the artwork. Several cracks, as well as some sites of loss and flaking, are visible in the frame's coating. However, the frame still possesses an acceptable appearance, despite the presence of these damages. The reverse of the frame appears secure and free of any detrimental damage or noticeable characteristics (apart from the framer's inscription 'Old Gold').

Image detailing the frontal appearance of the frame. Noticeable characteristics and damages have been mapped: darkened discolouration of broadest frame segment (outlined in yellow); cracks and flaking of the frame's coating (outlined in red).

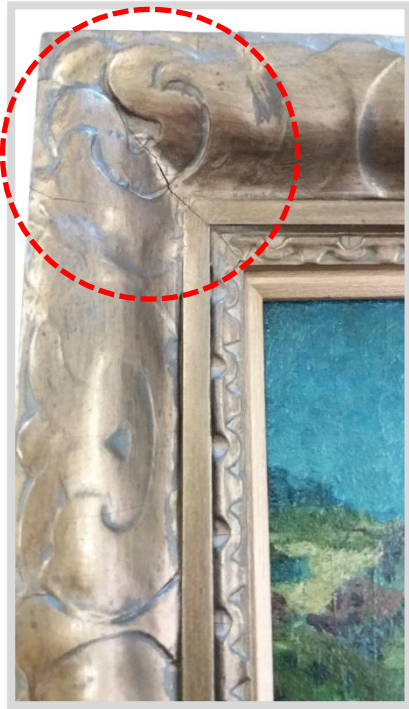
1. Close-up image detailing frame cracks (circled in red) in the upper, left-hand corner.

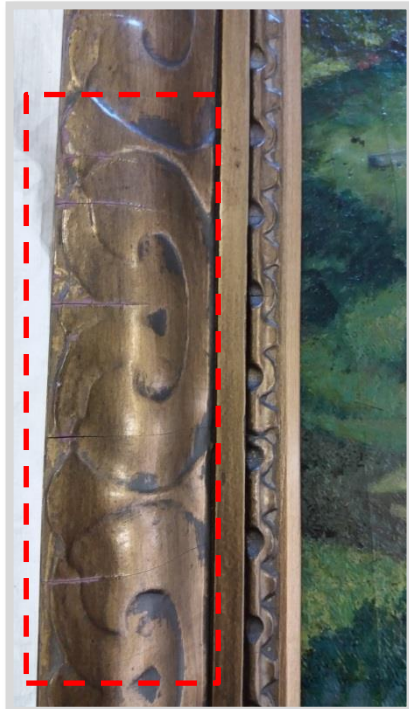
2. Close-up image detailing frame cracks and coating losses and flaking (outlined in red) on the left side of the frame.

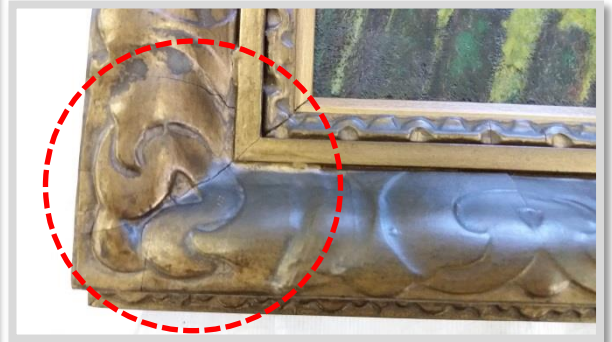
3. Close-up image detailing frame cracks (circled in red) in the lower, left-hand corner of the frame.

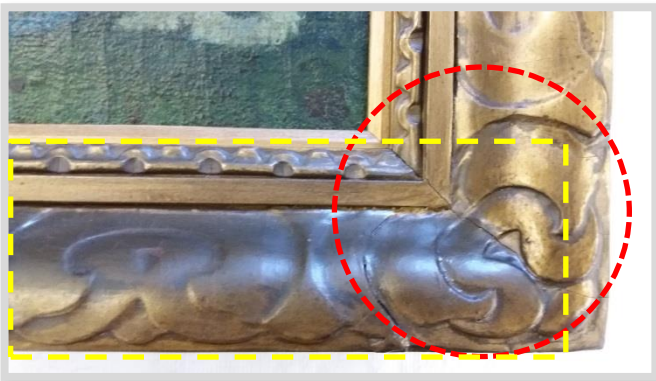
4. Close-up image detailing frame cracks (circled in red) in the lower, right-hand corner of the frame. The darkened discolouration of the lower and broadest segment of the frame is also visible (outlined in yellow).

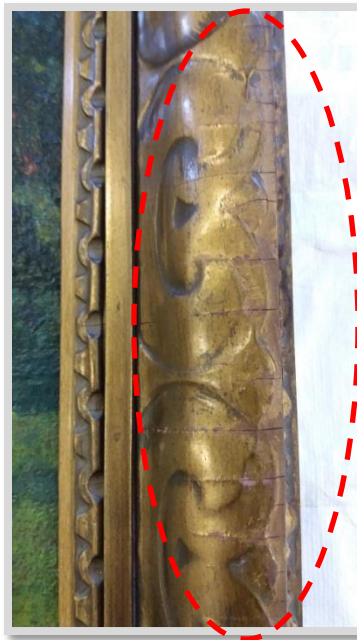
5. Close-up image detailing frame cracks and coating losses and flaking (circled in red) on the right side of the frame.

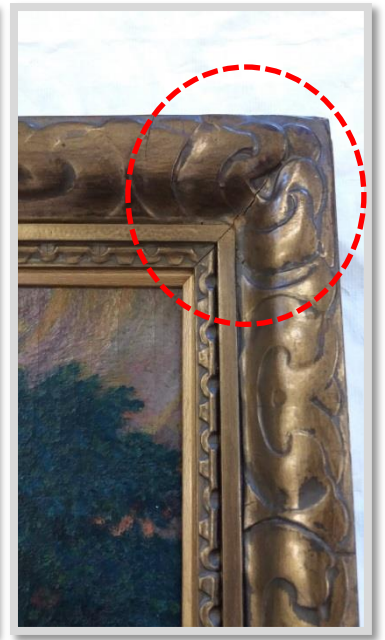
6. Close-up image detailing frame cracks (circled in red) in the upper, right-hand corner of the frame.
