CONDITION REPORT  
IDENTIFICATION DETAILS

Edward Wolfe  
1897 - 1982

Aishia  
Portrait of a women.

Elize de Beer  
2016

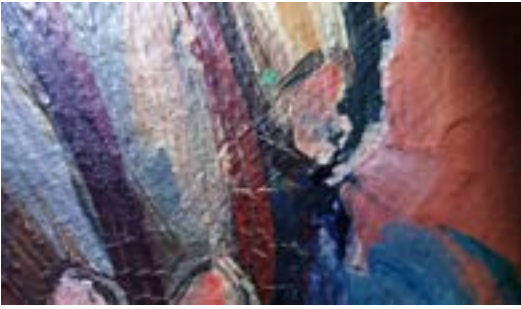
Figure 1

Refer to Crack Figures 1; 5-21; 24-26.

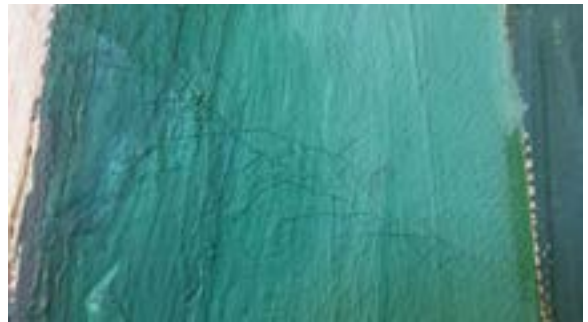
Figure 4

There is a fish tail crack which is caused by a firm markers pressing onto the back on the canvas that has left the crack behind. Refer to Crack Figure 4. When looking at the area in Raking Light, it shows how something pressed against the back of the canvas causing the cracks and how it has left a dent in the canvas.

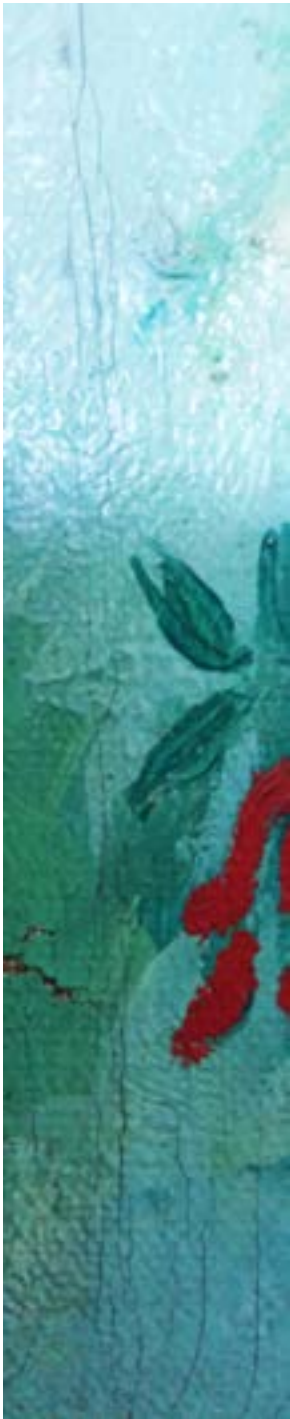
Figure 22

Along the left side of the painting is a crack running from top to bottom 20mm from the edge of the painting. A stretcher would create this type of crack and when the painting was removed from the stretcher this crack would remain. This gives evidence to that fact that it is now not in its original secondary support structure. Refer to Crack Figure 22. It can also be seen clearly though racking light.

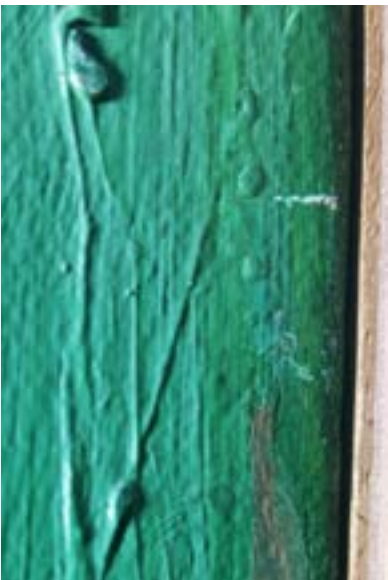
Figure 7

Scratches in the paint layer show how the painting has been mishandled. Refer to Chip and Abrasions Figures 7 and 12. The loss of paint and ground has also been a cause of the compromise of the primary support. This compromise has been caused by the tack holes that run along the left side of the painting. The holes have caused the paint and ground around them to fade. Over time if not repaired the paint loss will increase in those areas. This applies to all chips and abrasions.

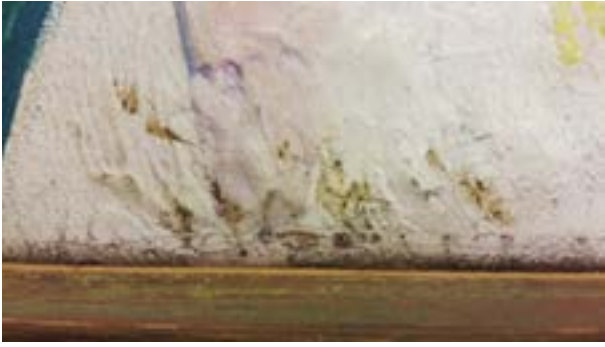
Figure 1

At the bottom of the painting there is some dirt accretion. It seems to be a splash of adhesive or sticky residue that has stuck to the painting and has then kept collecting. Painted Surface Figure 1.

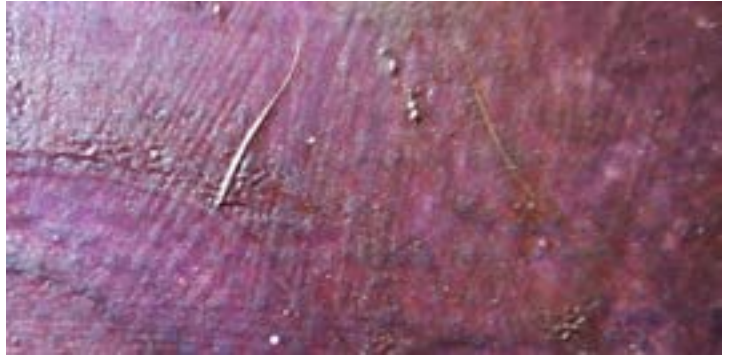
Figure 2

There are two small hairs in the sash of the women's cloths. It is hard to locate at first because of how thick Wolfe's paint layers were and in relation to the drying cracks that surround it. Figure 2.

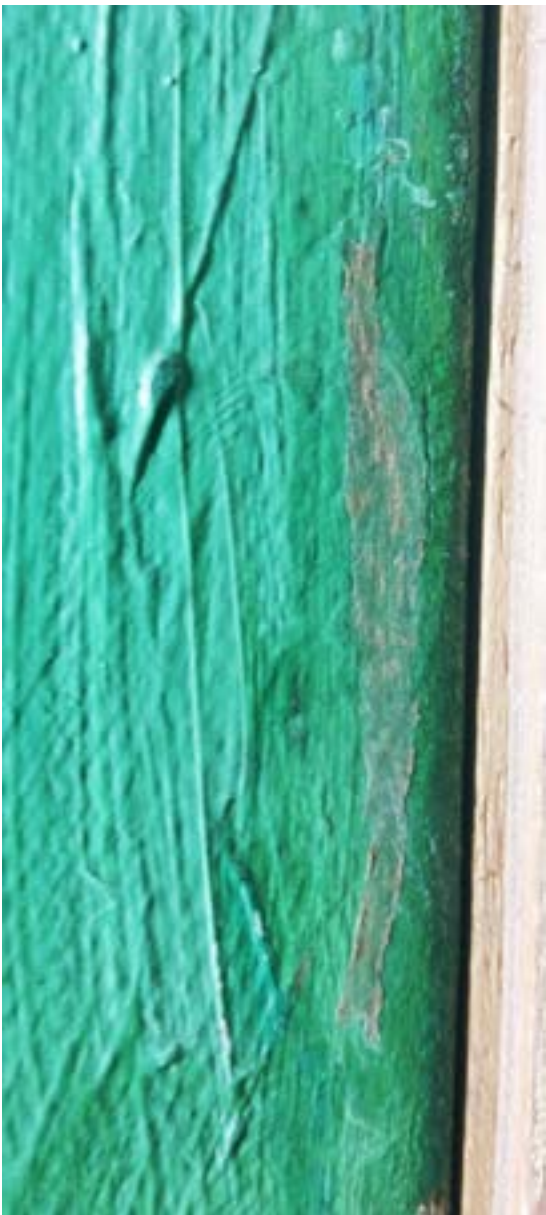
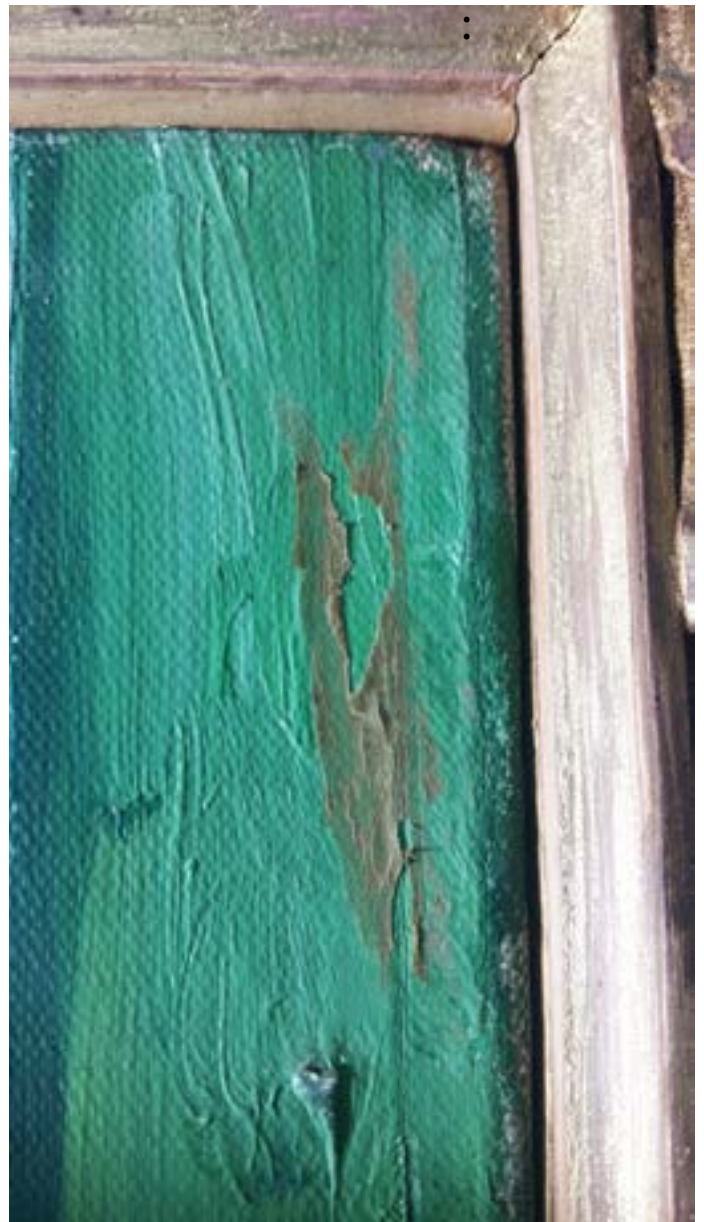
Since Wolfe painted in impasto the pronounced brushworks have the potential of trapping dirt and dust in the groves of the paint if the painting is not looked after properly. There is brown gum trap residue along the top right of the painting and in the middle. – adding evidence that this is not the paintings original secondary support. Refer to Painted Surface Figure 3-4.

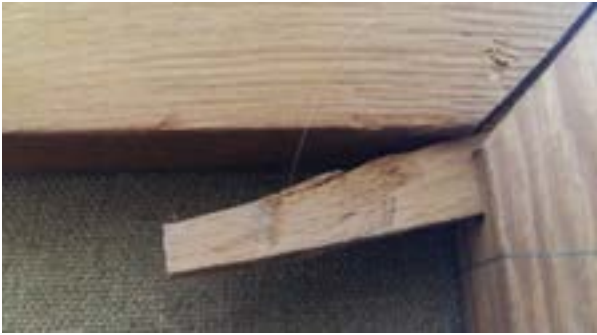
Figure 3

Expansion keys: 7 keys, 1 missing and one damaged in the top right hand corner. They have been taped in (Figure 3)

The members at their mitre on the left bottom, left top and right bottom corners there is a gap between the joints. However the explanation keys are still able to hold the joint in place to the support structure stable and taught. Damage can be seen in Figure 3, 4 and 5.

There are dents assumingly due to the secondary support having been mishandled; due to the fact that a soft wood was used or inadequate construction of the support. There are some cracks and chips of wood missing, especially in the inner corners of the support. See figures 3, 4, 5 and 7.

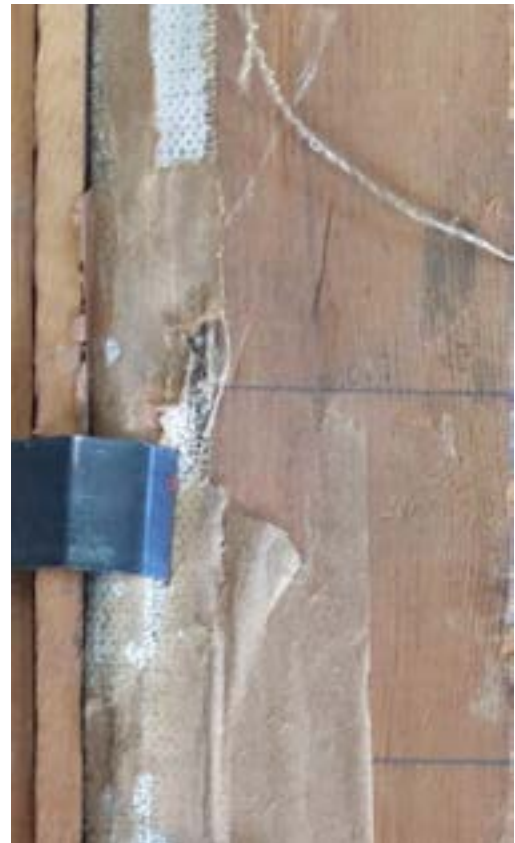
Figure 8

Gum Tape residue and bits of tape is still on. Suggesting it was torn off to remove it from the original. The tape has been cut or torn to remove it from the original support. Seen in Figure 7 and 8. There is also Gum tape stuck on the painted surface of the painting on the right hand top corner and centre with adhesive residue.

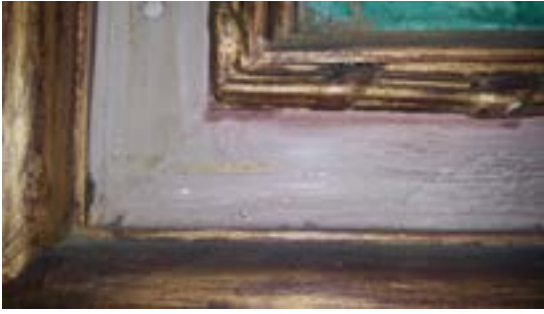
Figure 1

Gesso is a traditional mix of an animal glue binder, chalk, and white pigment, used to coat rigid surfaces such as wooden painting panels as an absorbent primer coat substrate for painting. Its absorbency makes it work with all painting media, including water-based media, different types of tempera, and oil paint. It is also used as a base on three-dimensional surfaces for the application of paint or gold leaf. I assume then that frame was made poorly especially in how the gesso and the frame paint layer was applied. As the paint layer and the gesso dried, the gesso began to bubble through the paint layers forming a hard white plaster like bubble on the surface of the frame. I assume this was caused by careless frame work or that it was done in damp/ humid conditions. Along the inner edges of the frame and in the middle section there are dark spots varied in size and shape of mould growing on the frame. Refer to Frame Front figure 1, 5-6 and 10.

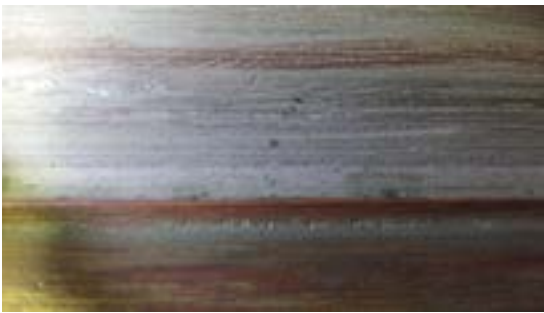
Figure 3

There are partials of dirt and dust that have built up on the frame, making the frame appear dull and lowering the condition of the frame. Among the dirt build-up there are also areas with mildew on the inner edges of the frame. Refer to Frame front figure 3, 6, 8 and 11.

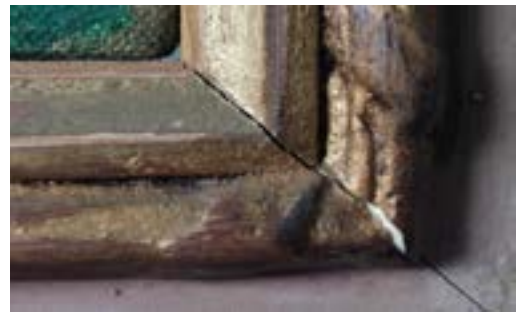
Figure 4

The structure of the frame is relatively sound. However there are cracks in the inner corners of the frame. Refer to Frame front figure 4 and 9. In the middle left member there is a hole, refer to figure 10.

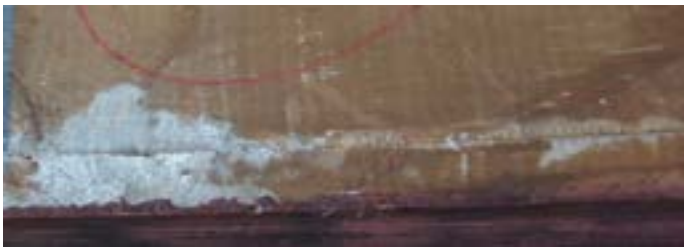
Figure 5

There are areas of the frame that have wood filler residue, showing signs of repair. Refer to frame-back figure 5, 8, 14 and 17.

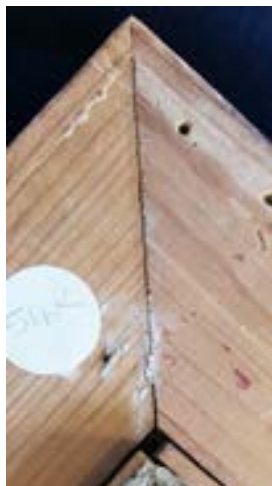
Figure 8

There are paint and red bole splats on the back of the frame when the front of the frame was being prepared, showing careless construction of the frame. Refer to frame-back figure 8 and 9.

Glue residue is also seen in areas where labels have been stuck down and where frame joints have been stuck together, refer to frame-back figure 8, 11 and 13.

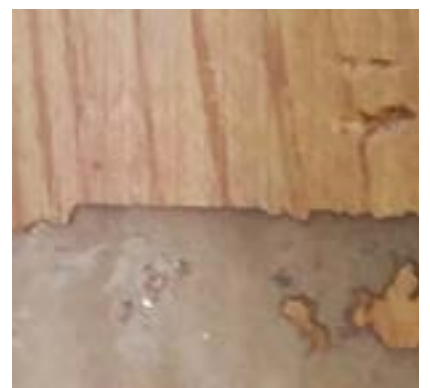
Figure 10

There are a few areas with dents, however not any that would compromise the structure, refer to frame back figure 10 and 12. There is a slight crack that runs through the left hand corner. It may need to be repaired so as to not continue the neglect of its poor condition.
